ALONG THE TOWPATH

Volume LVI December 2024 Number 4

Building Blocks of the Canal: The Log Wall

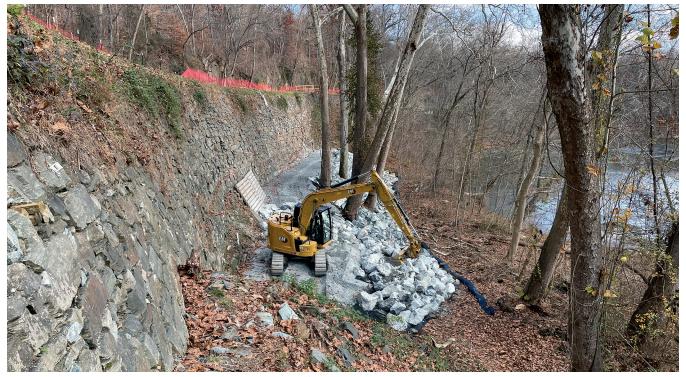
The building of the Log Wall upstream riprap buttress – Photo by C&O Canal NHP Professional Services Division

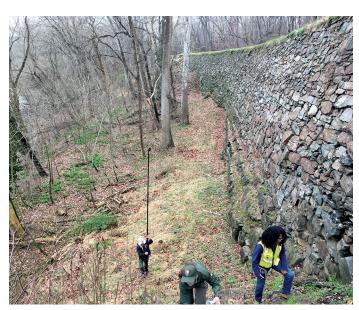
A 2020 upstream view of Log Wall before project work began – Photo by C&O Canal Professional Services Division

Around 2015 and 2016, sinkholes began to form in the canal above Log Wall. The area was temporarily stabilized by dewatering this stretch of the canal and by using sandbags to prevent water from further infiltrating into the sinkholes and stone wall. The dewatering efforts impacted a 4-mile stretch of the canal from Lock 14 at Mile 9.47 upstream to Lock 15 at Mile 13.45. This stretch of the canal includes the Widewater area at Mile 13, which is a relic channel of the Potomac River and ranges anywhere from 50 to 80 feet wide.

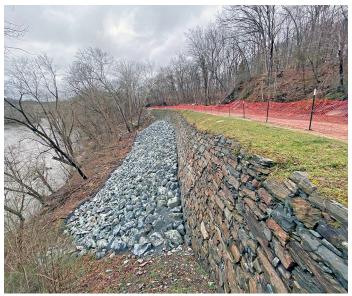
A March 2024 upstream view of Log Wall after repairs – Photo by C&O Canal Professional Services Division

As part of the stabilization project work, the masonry of the stone wall was repaired to reduce future instability. Earlier site visits indicated that there was movement of the stone masonry units comprising the wall. Repairs and stabilization efforts included providing stone infill and repairs to the face of the existing stone wall. In addition, a small section of the dry-laid stone masonry buttress supporting the upstream side of the wall was rebuilt. Once repairs to the wall were completed, a crushed stone gravel "core" was installed and armored with heavy dumped stone (riprap) to prevent erosion during flood events.

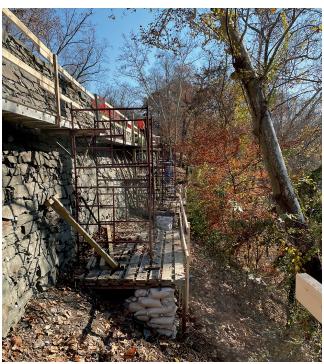
Top: A pedestrian bypass detour around the project site. Middle: Tree removal along Log Wall. Bottom: Repairs to the stone masonry. All photos by C&O Canal Professional Services Division

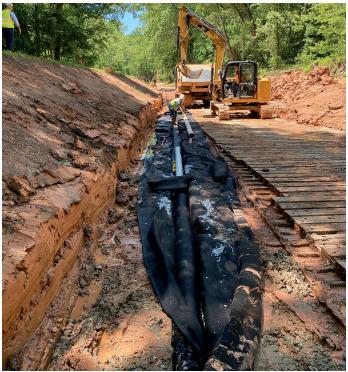
The installation of an underdrain system within the canal prism – Photo by C&O Canal Professional Services Division

The HDPE liner is protected between layers of sand and geotextile and is covered with a blanket of clay. Internal drains – comprised of clean gravel, perforated drainage pipe, and geotextile – are also included to intercept any groundwater or control any leakage under the liner system if there is future damage.

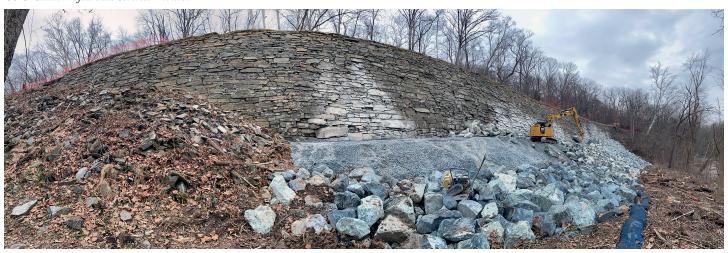
Panorama view of the construction of the upstream buttress – Photo by C&O Canal Professional Services Division

This dumped stone at the face of the wall provides a resisting pressure to stabilize lower

courses of the wall and buttress it from further movement. Dumped stone buttressing was the primary method used to reduce the effective height of the retaining wall and pressures within it. Historically, this method was used at the site and kept reaches of the wall in-place. During design development, a series of options were considered with buttressing being the most effective, in lieu other more intrusive methods such as full wall disassembly and reassembly.

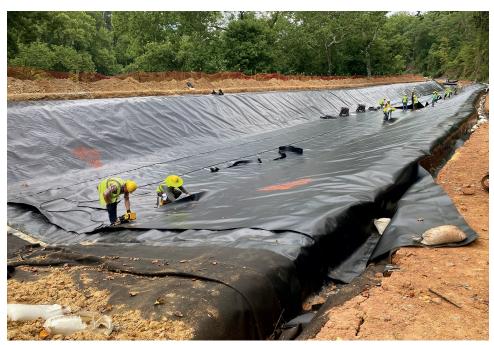
The installation of the canal prism liner – Photo by C&O Canal Professional Services Division

To stop the growth of the sinkholes and their impacts to the wall and towpath, a specially designed gradation of materials – sands and gravels – infilled the existing sinkholes. The canal liner was also replaced with a geosynthetic system. The new 40-mil High Density Polyethylene (HDPE) liner limits leakage through the towpath and the wall.
