RILEY FAMILY HISTORY

Including the memories of
Joan Paull
Volunteer at Riley's Lock (Lock No. 24)

Written by
William Bauman
C & O Canal Association Volunteer

OCTOBER 2009

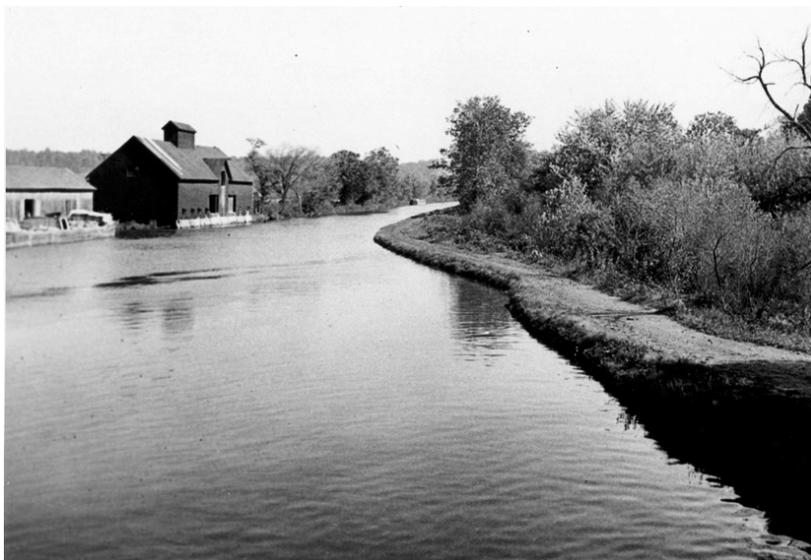
What with the quarry, the canal and an agricultural society it wasn't too long before a community developed. Evidence of that community was the construction of a warehouse and other buildings along the canal for the stowage of agricultural products; various grains for shipment to Georgetown and fertilizer from the seaport at Georgetown. Looking closely at the berm side

warehouse in the adjacent photograph, large doors could have been used for loading and unloading items such as bales of hay or bags of fertilizer. The four smaller openings on the near side of the large doors could have been openings for chutes; the granaries at Whites Ferry and Monocacy had similar openings. The bins behind the openings would have kept the bulk corn separate from the bulk oats, wheat, rye, etc. Warehouses and/or granaries were typically built on the berm side of the canal so that boats loading or unloading would not impede traffic.

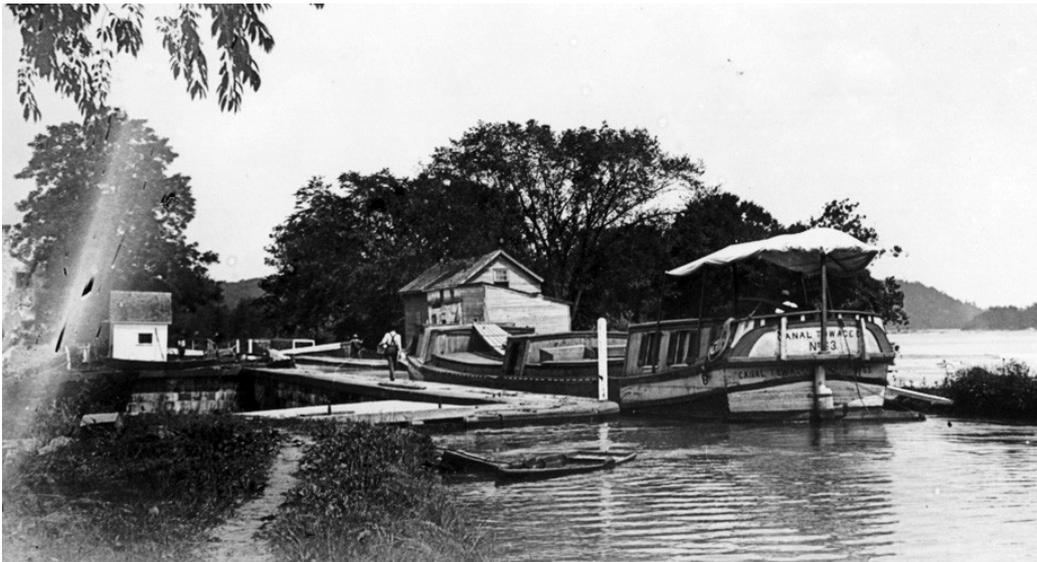
In the adjacent photograph, the boat entering Seneca Creek Aqueduct is labeled "Canal Towage No. 3" dating the photograph as during

the receivership period. Notice the nearly submerged rowboat, just above the rowboat was the waste weir in the berm abutment of the aqueduct, the white "wait house" and two unidentified structures on the river side of the canal; the Alnutt store was one of the structures. That is the Potomac River to the far right.

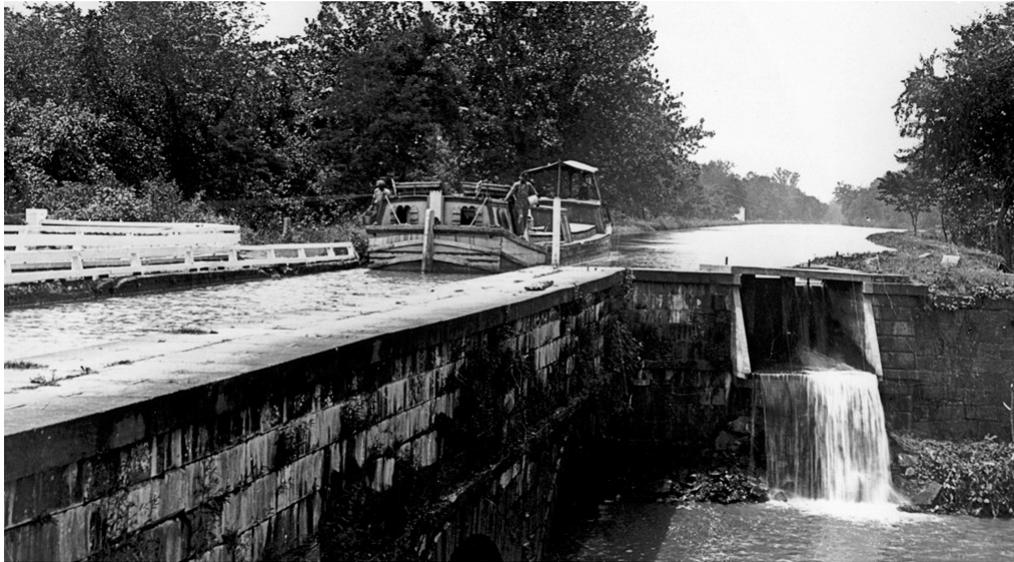
The photograph on the next page shows a similar, loaded canal boat also with an awning over the cabin, entering Seneca Creek Aqueduct. The previously mentioned waste weir is more evident in this view looking westward. The low white railing provided visibility to the edge of the aqueduct whereas the high white railing on the other side of the towpath was helpful in preventing mules or men from falling into Seneca Creek.

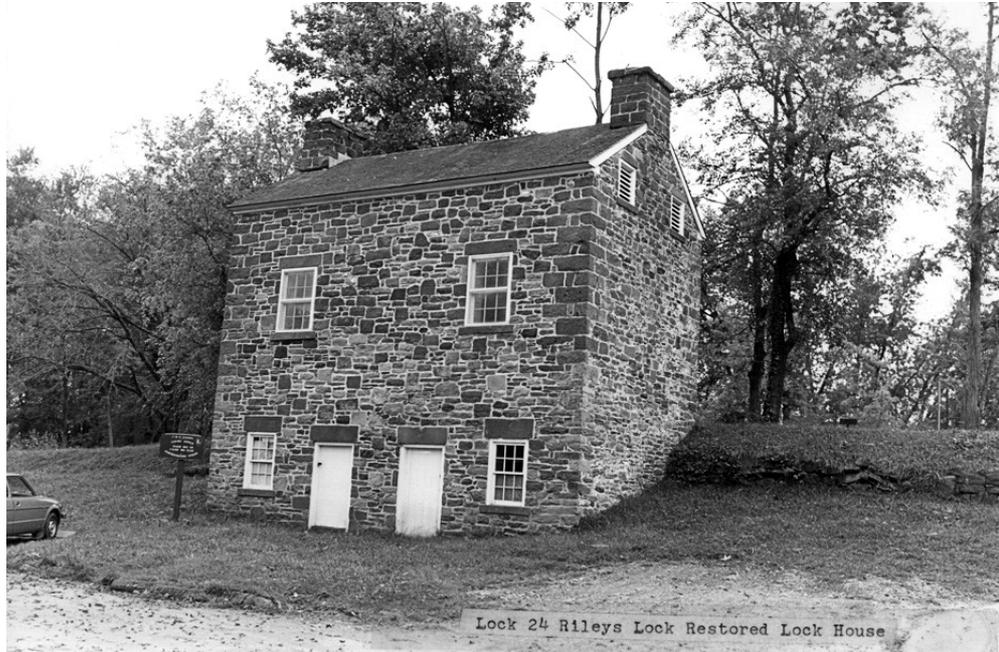
Lock 24 Rileys Lock Restored Lock House

kitchen in the basement was used in the summer. While the following photograph was taken after the lockhouse and grounds were restored, it does show the back of the lock house as

Raymond Riley remembered it, with the two ground floor doors evident. The kitchen, on the left or east side for this lock house, would have had a tall fireplace with suitable cooking cranes for the meal preparation. The first floor included a living room and a parlor; the

parlor was on the right or west end for this lockhouse. Joan Paull and the Girl Scouts used the parlor as their visitor interaction room; it had the fireplace for the first floor although the fireplace was not operational. The second floor contained the two bedrooms, each had a fireplace and so only two flumes were needed for each chimney.

Raymond Riley remembered the lockhouse as having two rooms on each floor, with a fireplace on each floor. The house at Lock 24 was of the "Type II" configuration, 18' x 30'. The basement, cellar or ground floor had two walk-out accesses; a workroom on one side and a kitchen being on the other side of the central stairs. Helen Riley Bodmer told Joan Paull that the

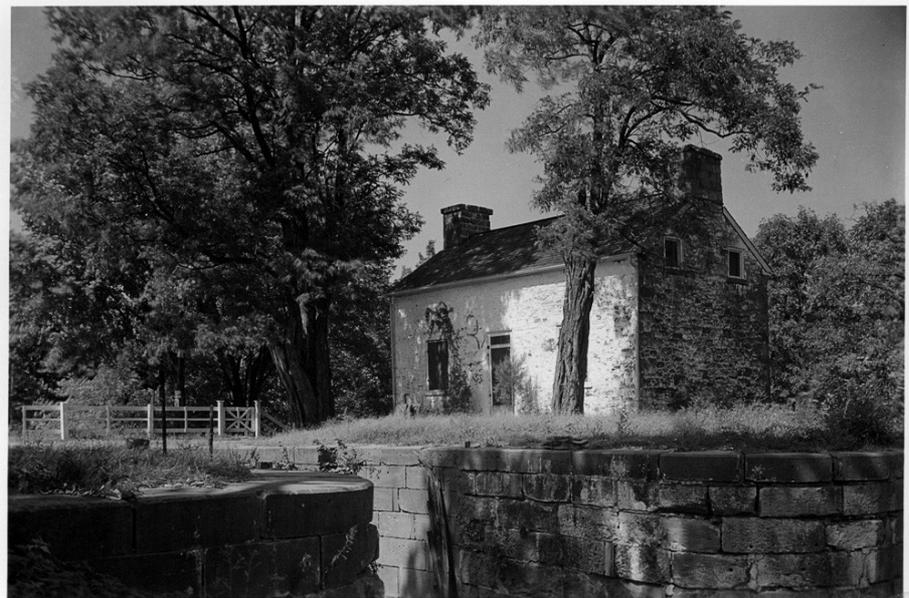
Lockhouse 24 - 1936

While the adjacent photograph was also taken after the canal closed, it does show the house had been whitewashed and set parallel to the canal; other lock houses were set perpendicular to the canal. For the upstairs bedrooms, there were no dormer windows but rather windows were built into the gable ends. Otherwise there were no windows in the ends of the lock house. The lock tender spent a lot of time in the wait house or on the nearby bench.

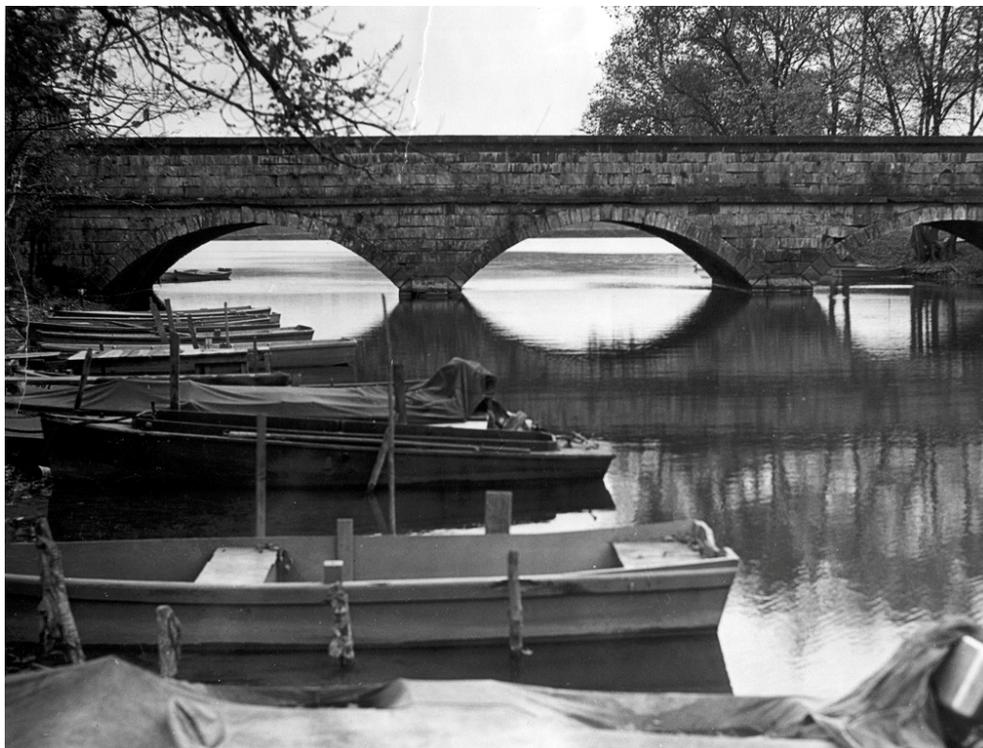
While the above photograph was undated (we know it was taken before Hurricane Agnes in 1963 because all three arches in the aqueduct were intact), it does show the available boats on the berm side of the aqueduct. It looks like two rowboats had outboard motors. To the left, near to the wing wall, was a spring where the Mr. Riley got their water; it has since been erased.

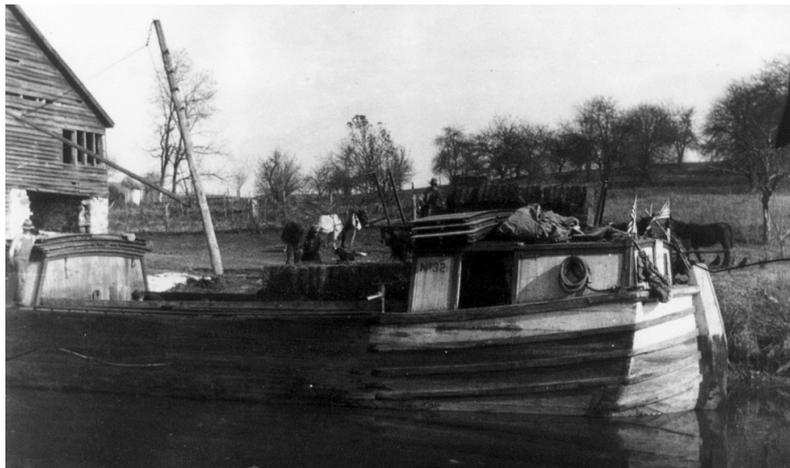
loading of 200# bales of hay from the berm, no wharf, but there was a derrick. Hatch covers served as gangways.

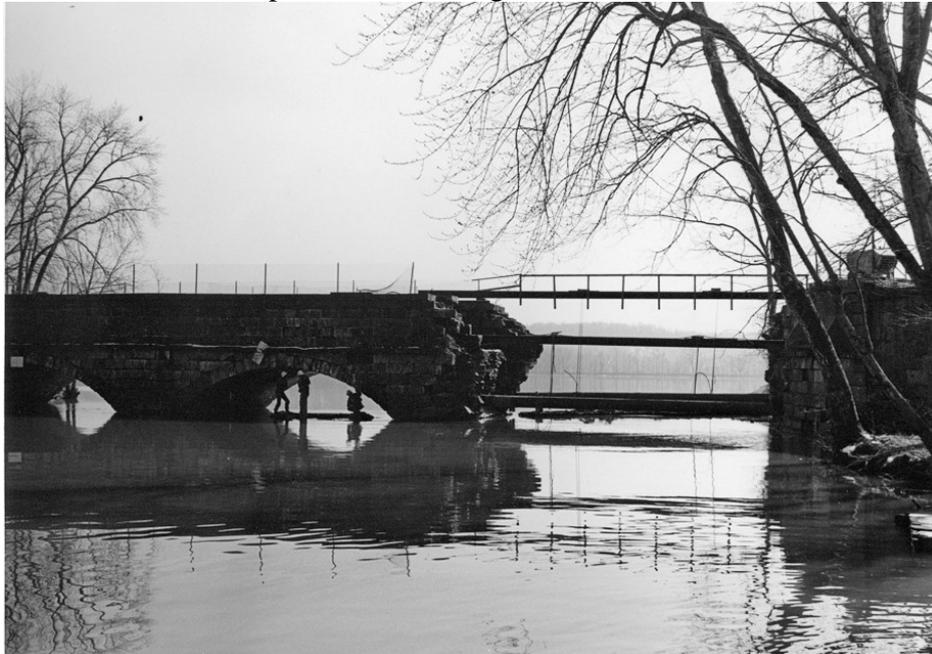
Approximately Sept. 11, 1971 a localized storm sent flood waters surging down Seneca Creek. The high water and debris resulted in the failure of the western arch of the aqueduct. In the photograph below, Park Service personnel standing on a float under the middle arch were

examining it for damage. The circular steel braces were already in place, as was the footbridge spanning the missing arch. Subsequently "Shotcrete" was applied to the exposed surfaces to protect them from the weather and further deterioration. The following photograph was taken

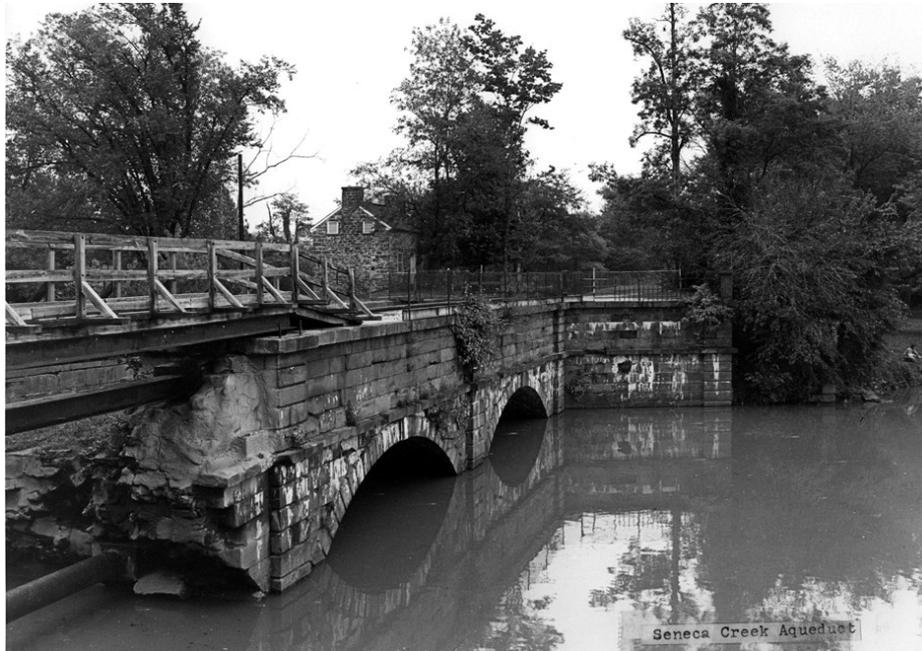
at about the same time, from the Potomac River side, looking east. Application of "Shotcrete" had already started, just below the pedestrian bridge, which was shown in better detail.

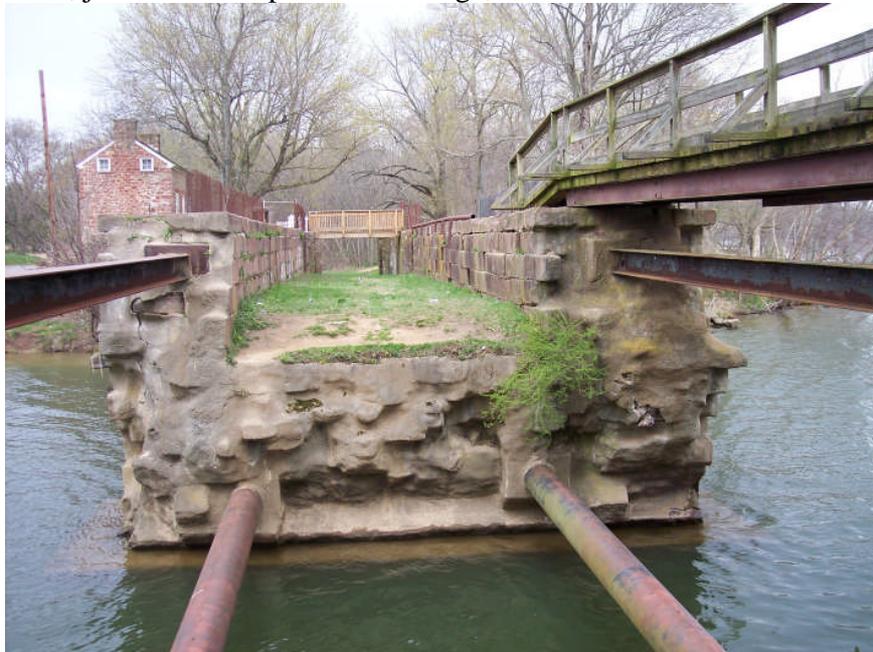
The above photograph was taken by the author in 2009 and illustrates that the application of "Shotcrete" has minimized further deterioration of the face of the fallen arch. Without the braces, the weight of the structure might have caused it to shift toward the viewer and thus jeopardize the integrity of the middle arch. The wooden pedestrian footbridge across the lock

gives visitors access to the towpath, and the pedestrian bridge across Seneca Creek, visible in the upper right hand portion of the photograph, maintains the continuity of the towpath. That is the Potomac River to the right of the aqueduct.
