# Recent Engineering & Construction along the Chesapeake & Ohio Canal

Chesapeake & Ohio Canal National Historical Park  
U.S. National Park Service – Department of Interior

Presenter: Joe Reed, P.E., CFM (Park Engineer)

Monday, August 30, 2021

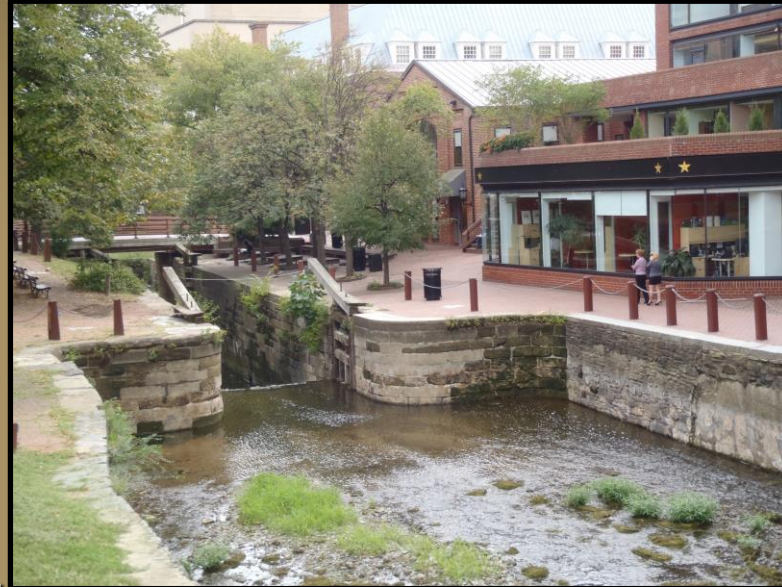
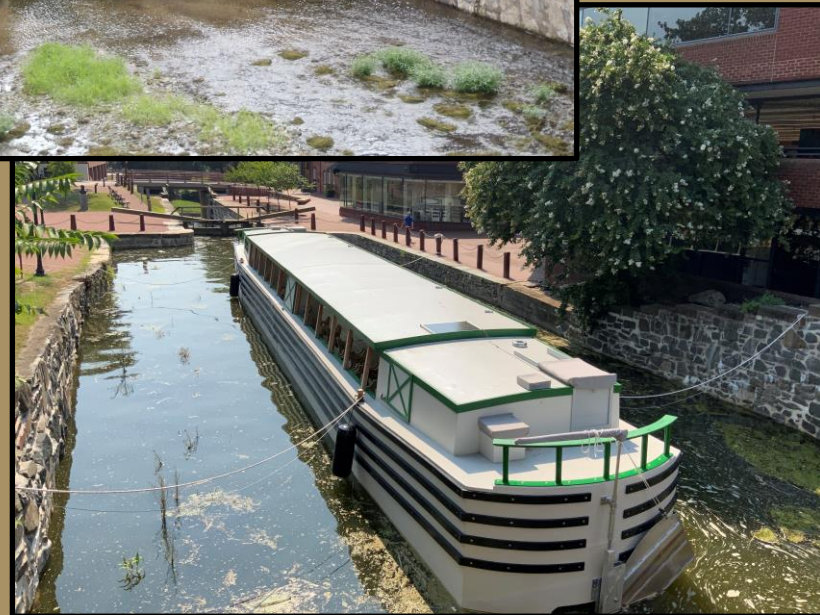
MM: 0.49 – 0.54 (Washington, DC)

- Construction contract awarded in September 2016 and substantially completed May 3, 2019.
- Rebuilt Lock #3 from the foundation up and salvaged existing stones where possible, installed stormwater management systems and hardscapes. Performed preservation maintenance on Lock #4.
- Total cost of construction approx. \$7.6 million.

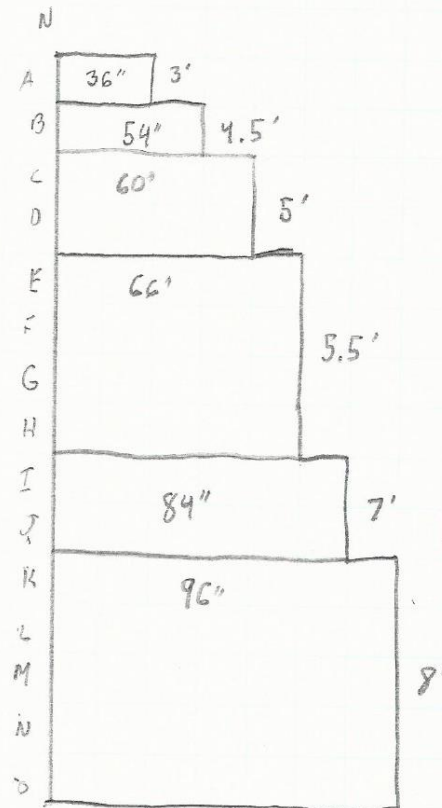
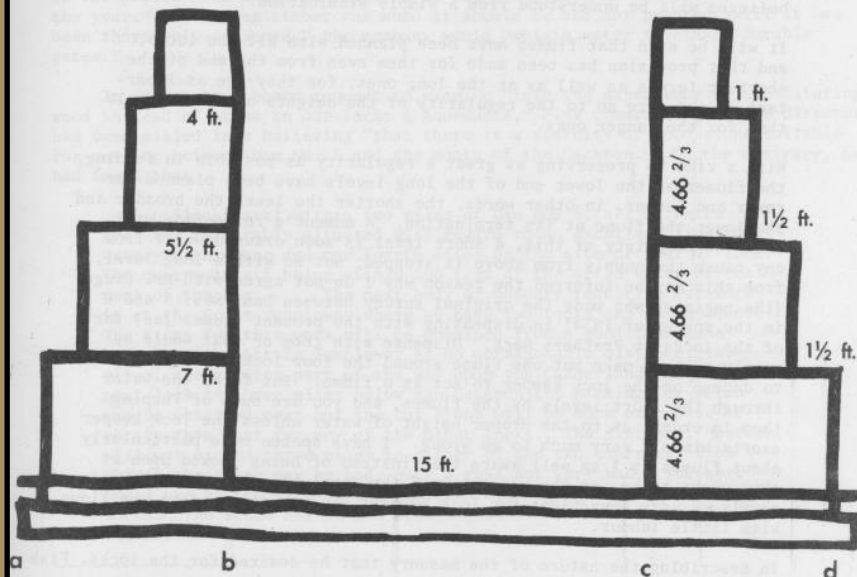
# TIMBER FOUNDATION OF LOCKS CONSTRUCTED BELOW DAM NO.5

FISK TO BENDER, JUNE 16, 1835.

DISASSEMBLE AND SALVAGE  
EXISTING COPING STONE

DISASSEMBLE AND  
SALVAGE EX LOCK WALL  
ASHLAR MASONRY FACE  
CONSISTING OF ORIGINAL  
SAND STONE AS WELL  
AS GRANITE AND BRICK  
REPLACEMENTS

EXISTING RANDOM RUBBLE  
MASONRY BACKING TO BE  
DISASSEMBLED AND SALVAGED

ASSUMED WALL CONFIGURATION IS  
INDICATED. DOCUMENT LOCATION AND  
SIZE BACK OF WALL STEPS. RESET  
RANDOM RUBBLE MASONRY BACKING  
MATCHING ORIG. WALL DIM.

EXIST. PLANKING AND  
FOUNDATION TIMBERS  
TO BE REMOVED

CULVERT ±7'-0" FIELD VERIFY ±15'-0" FIELD VERIFY ±7'-0" FIELD VERIFY  
CULVERT. DOCUMENT SIZE  
AND LOCATION DURING  
DISASSEMBLY

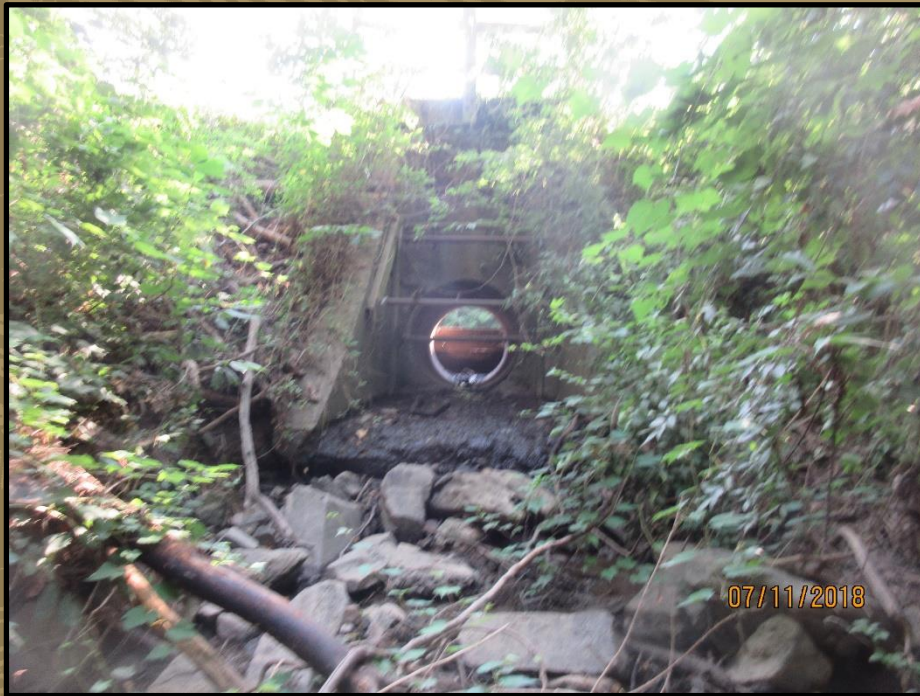
Level 7 (near Lock #7) Repair

Before

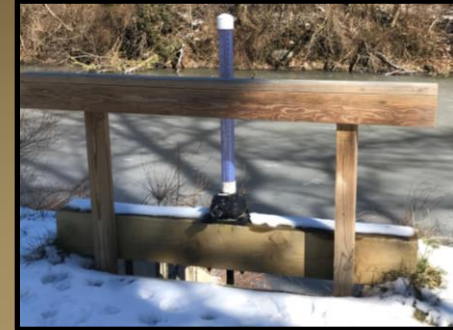
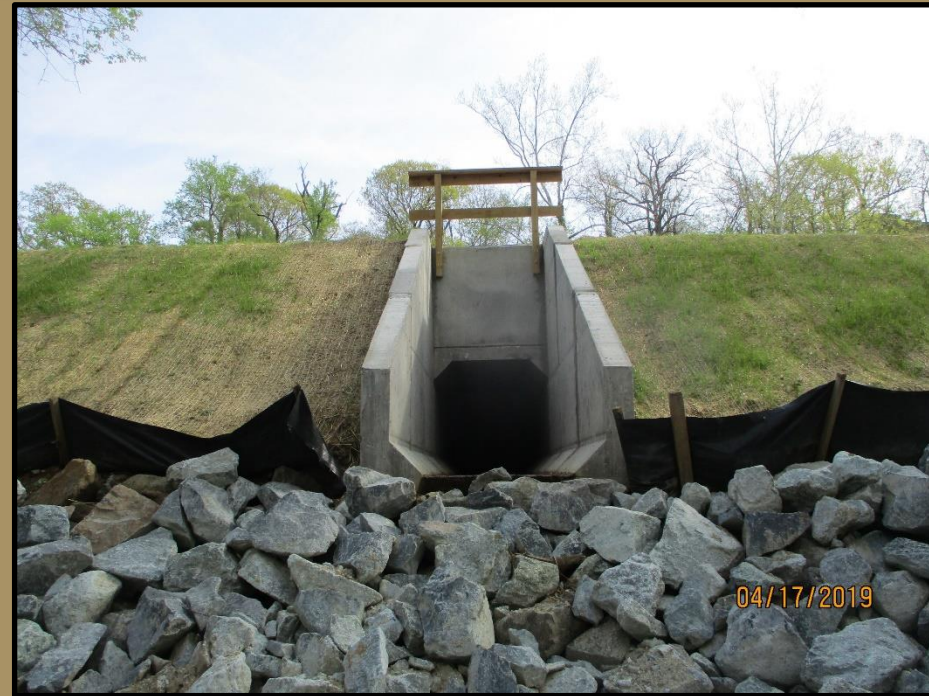
After

Emergency fuse plug spillway also installed just upstream of Lock #7 to increase flood resiliency by providing a protected point of overflow out of the canal!

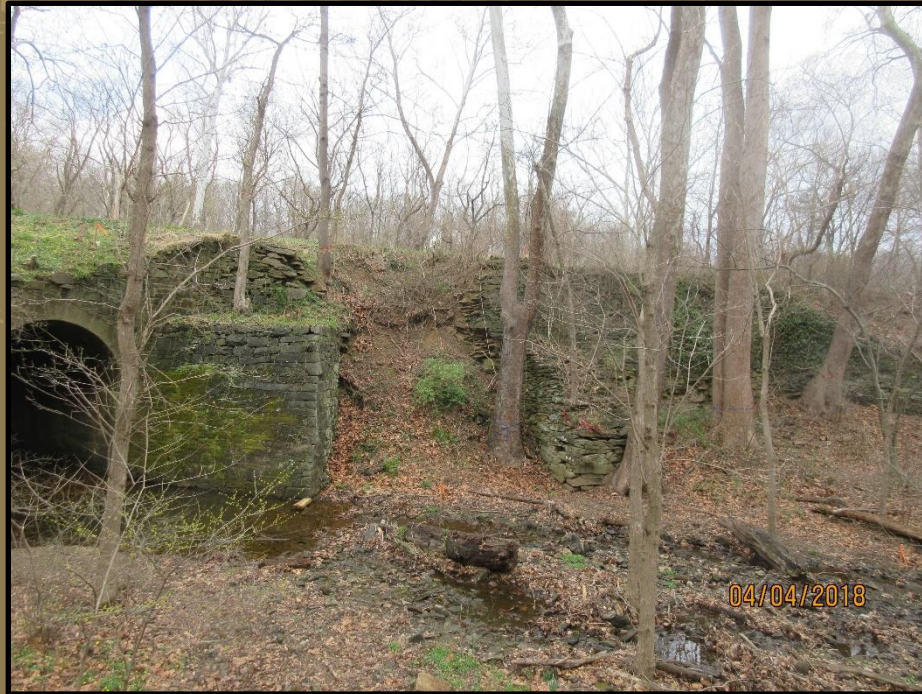
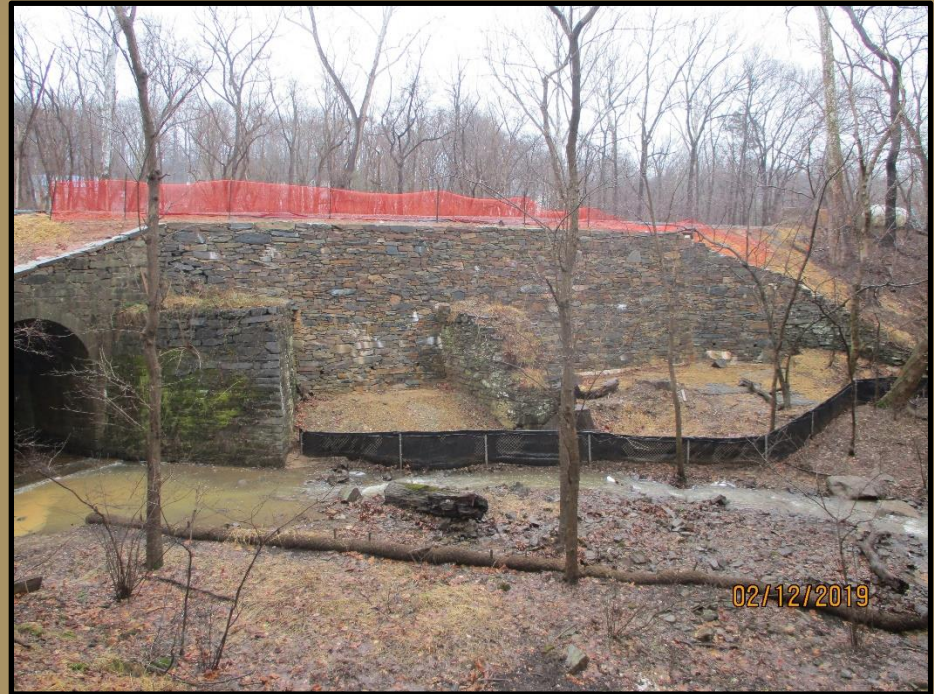
Rock Run (near Lock #10) Repair of Drylaid Stone Wall Supporting the Towpath

Before

After

Canal liner system also restored!

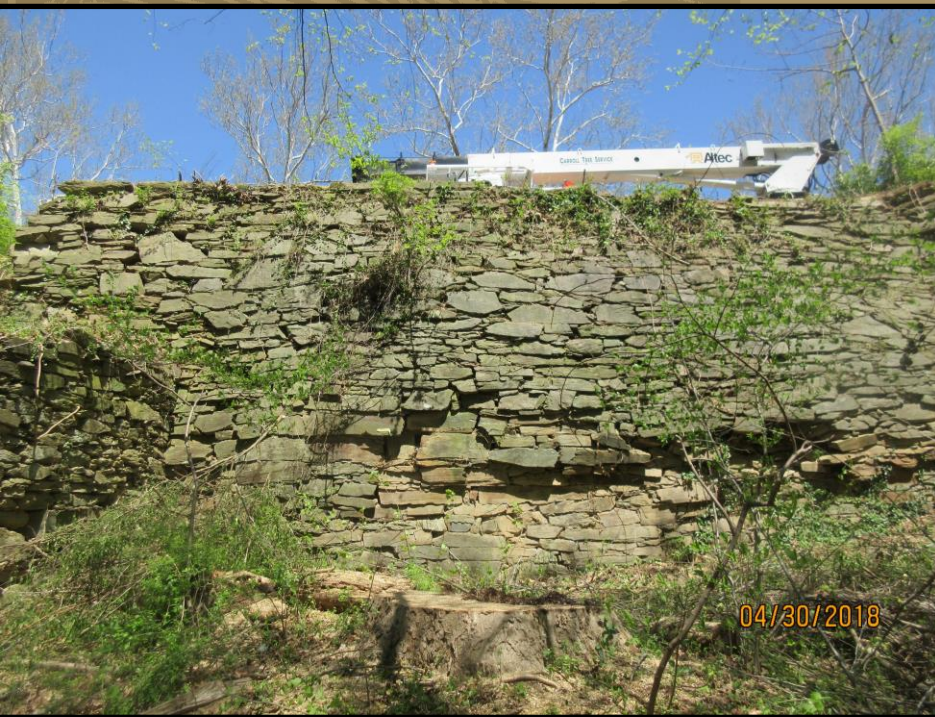
Rock Run (near Lock #10) Repair of Drylaid Stone Wall Supporting the Towpath

Before

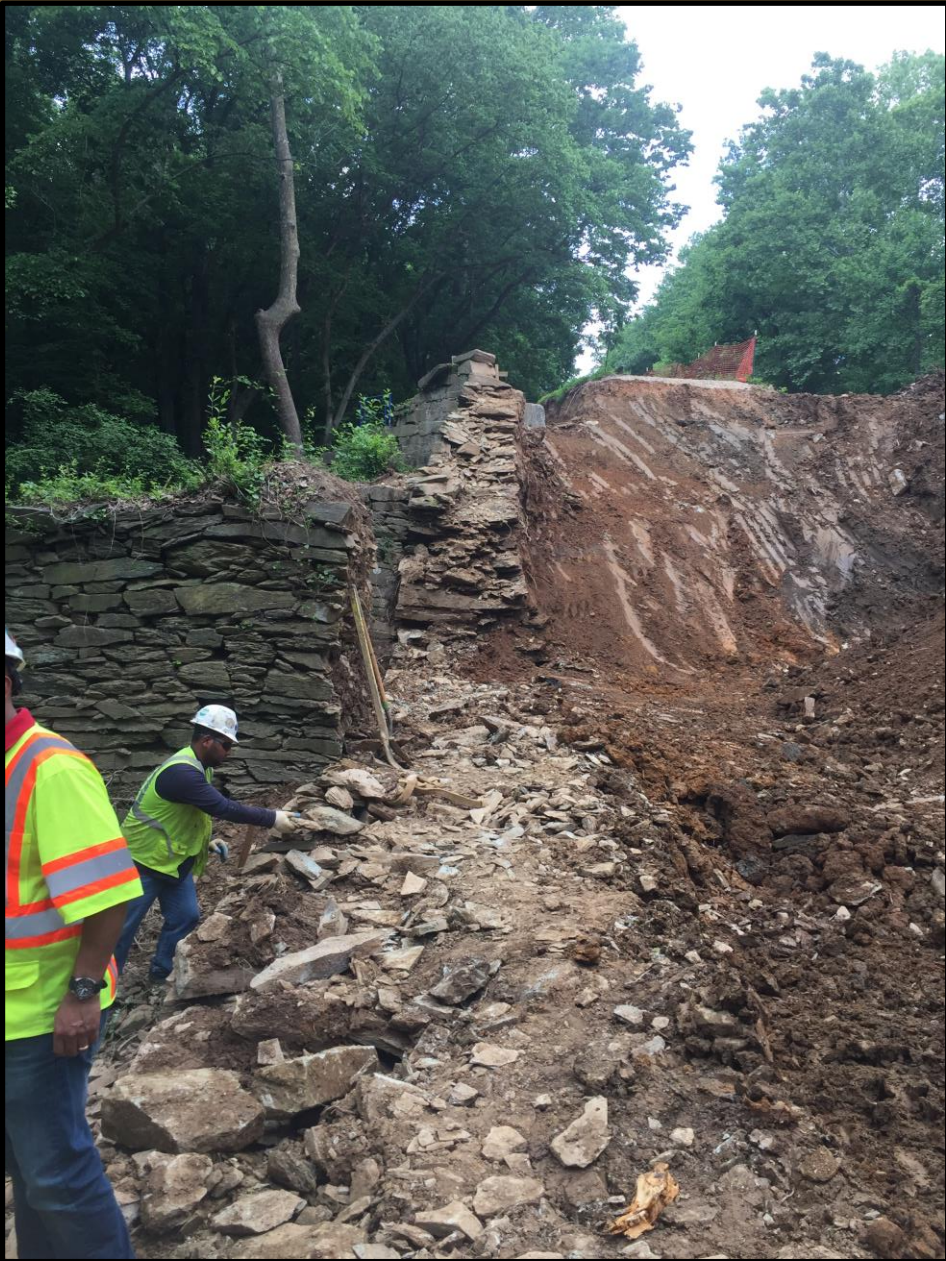
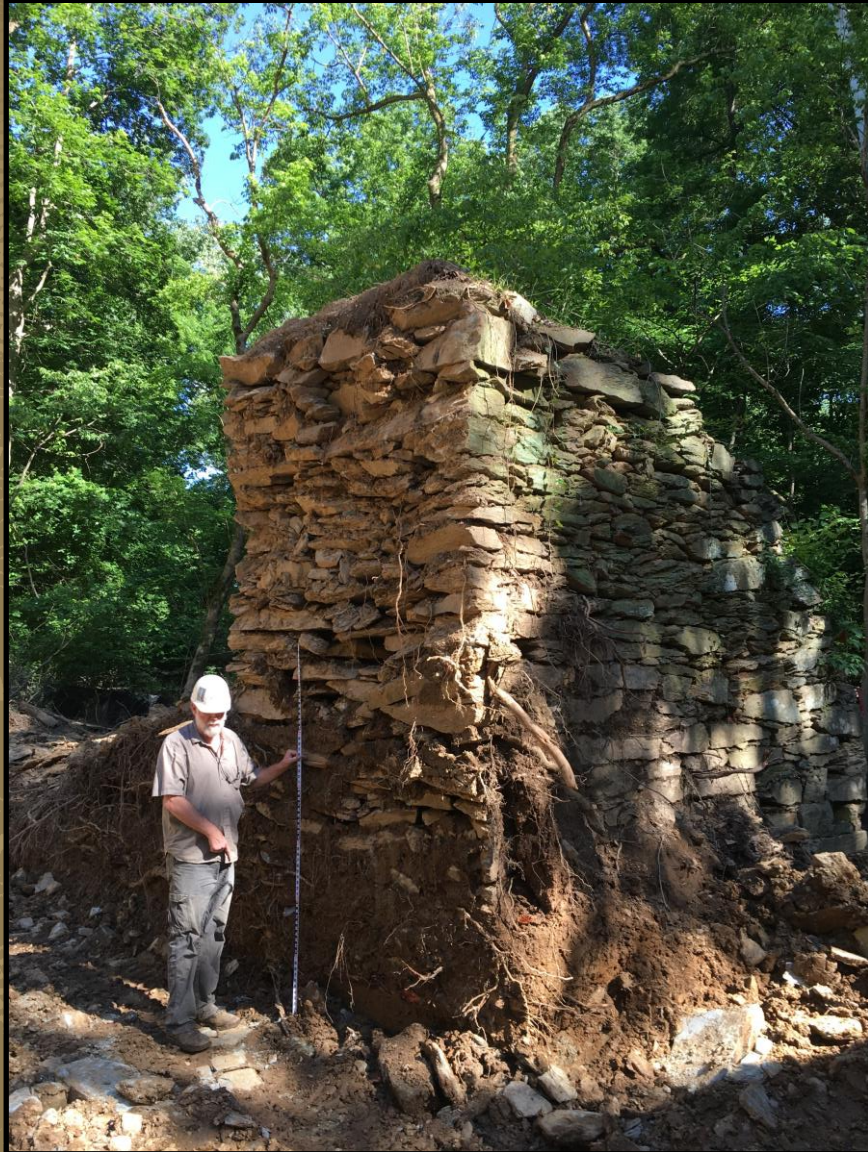
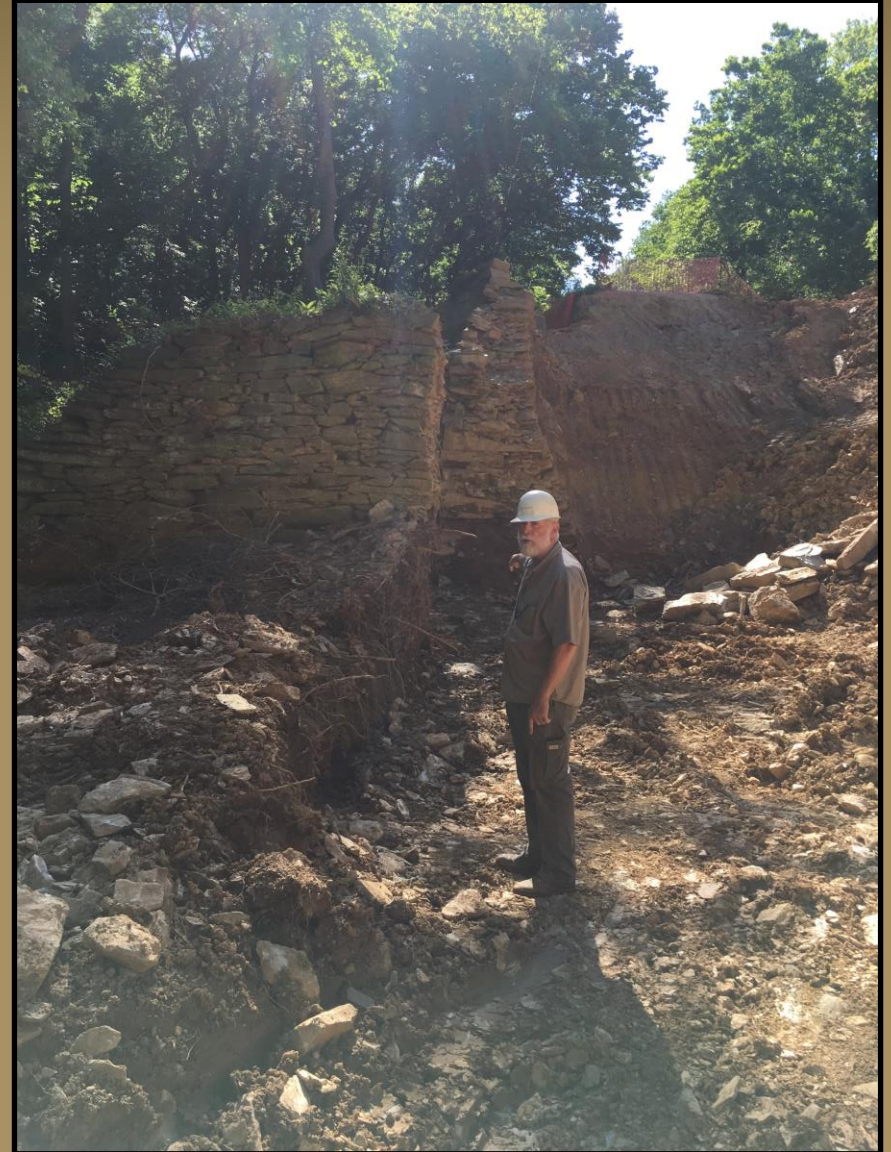
After

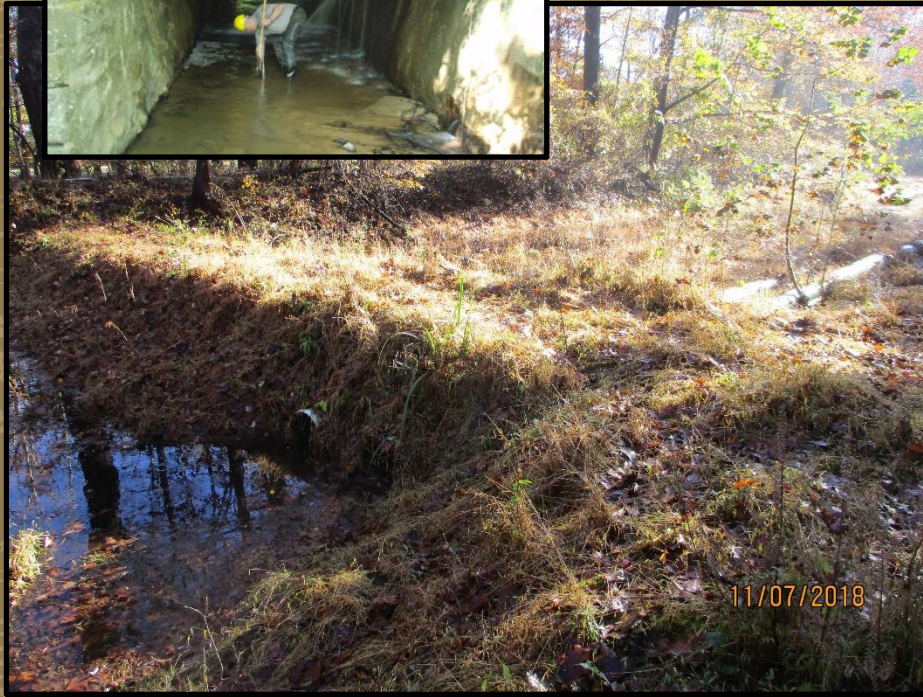
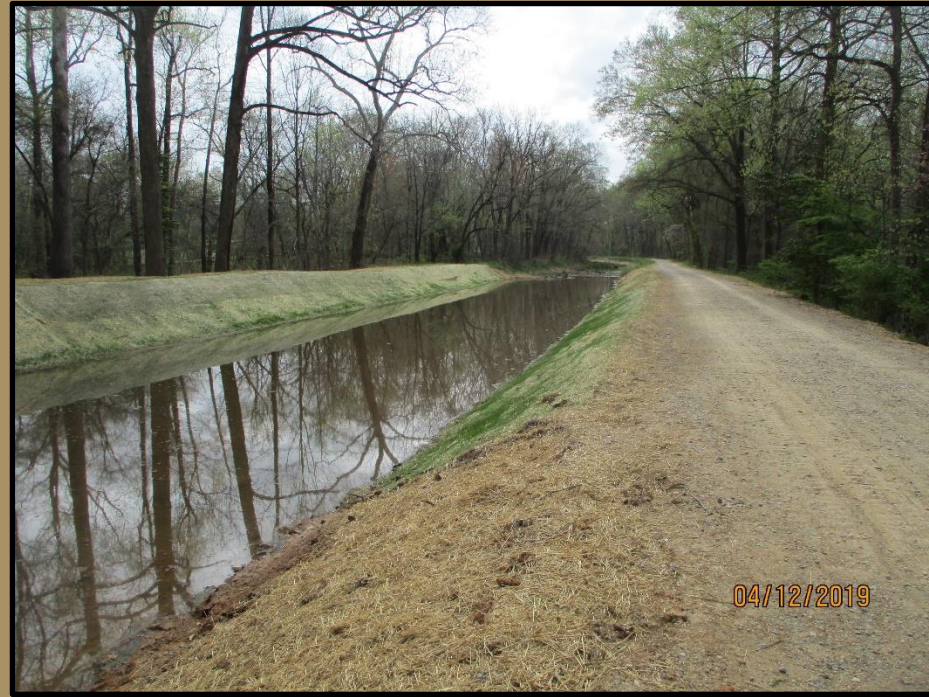
Culvert 15 (near Carderock) Repair

Before

After

Cofferdams and bypassing pipe removed from canal, regraded liner installed, sinkhole filled, and underlying historic masonry culvert repointed!

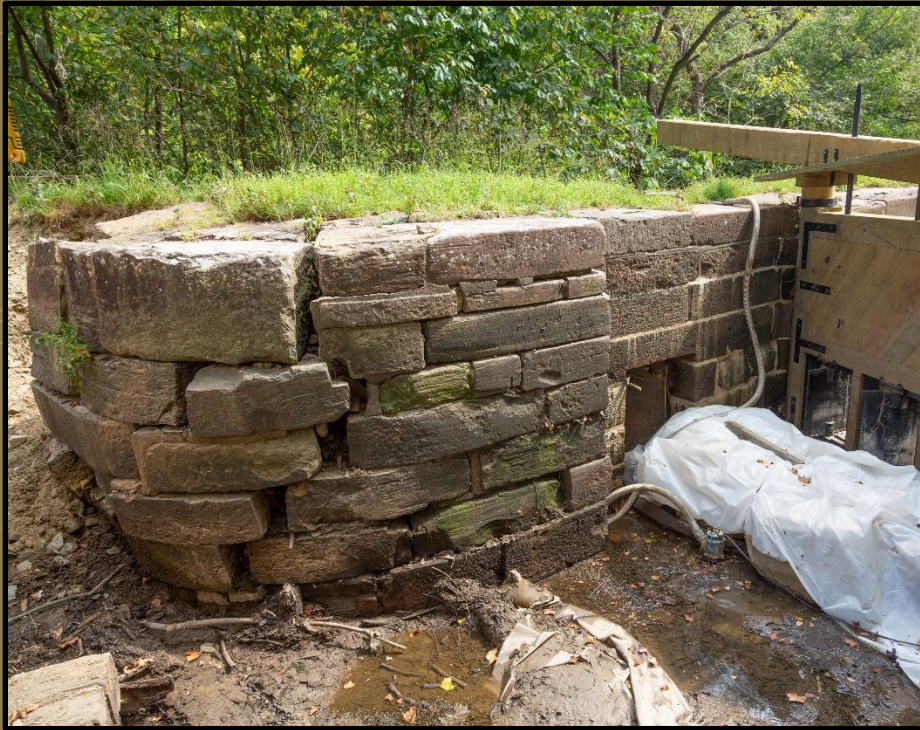
Lock #17 Riverside Wall Repair

Before

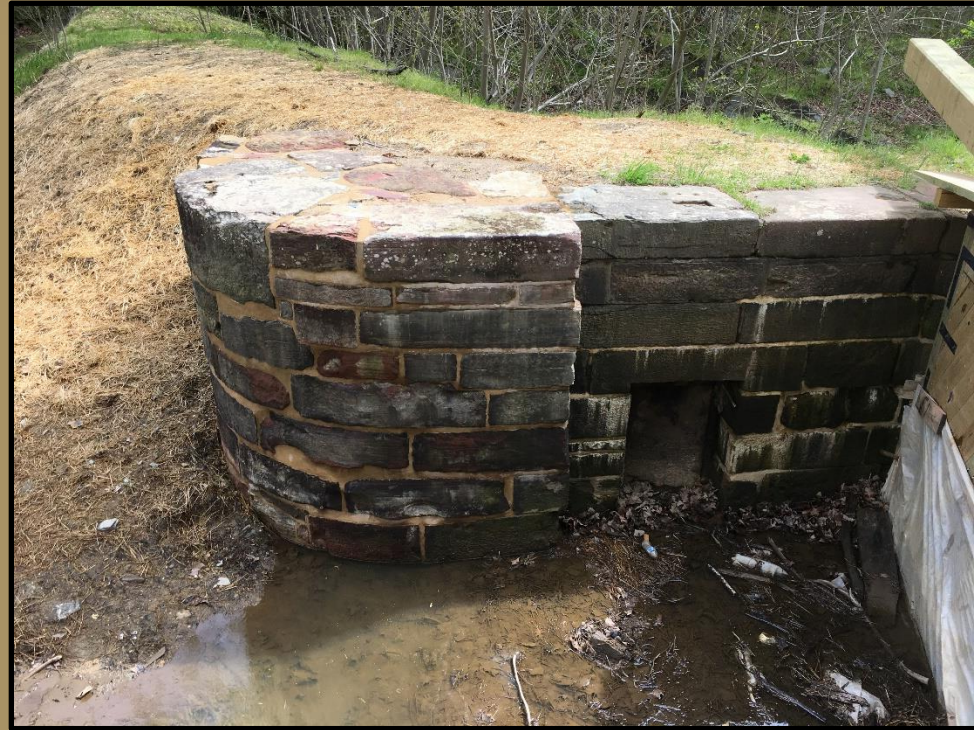
After

Lock gates replaced and masonry repairs were also completed!

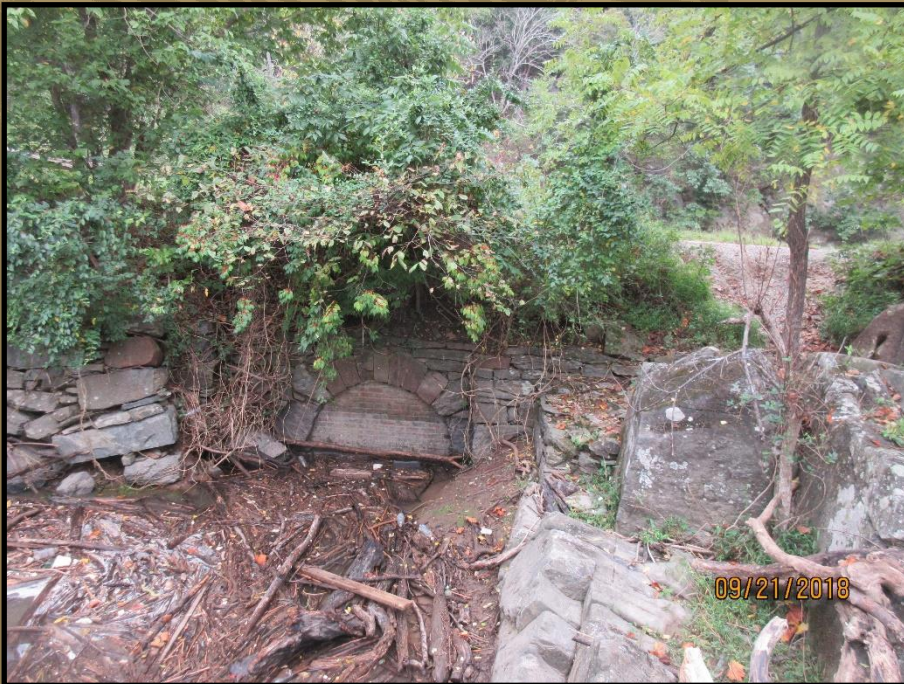
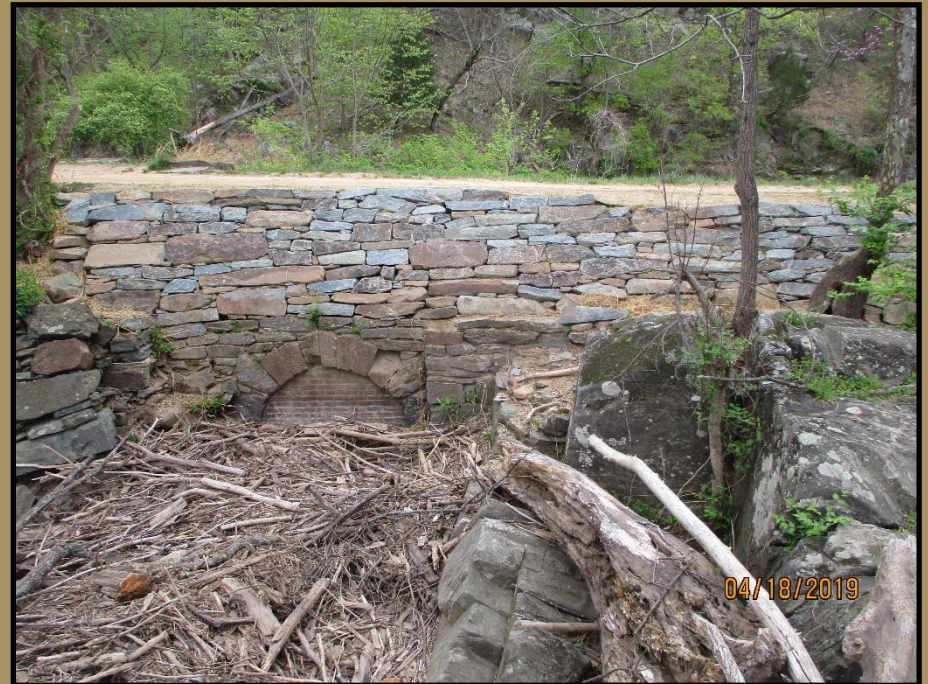
Lock #18 Riverside Wall Repair

Before

After

Lock gates replaced and masonry repairs were also completed!

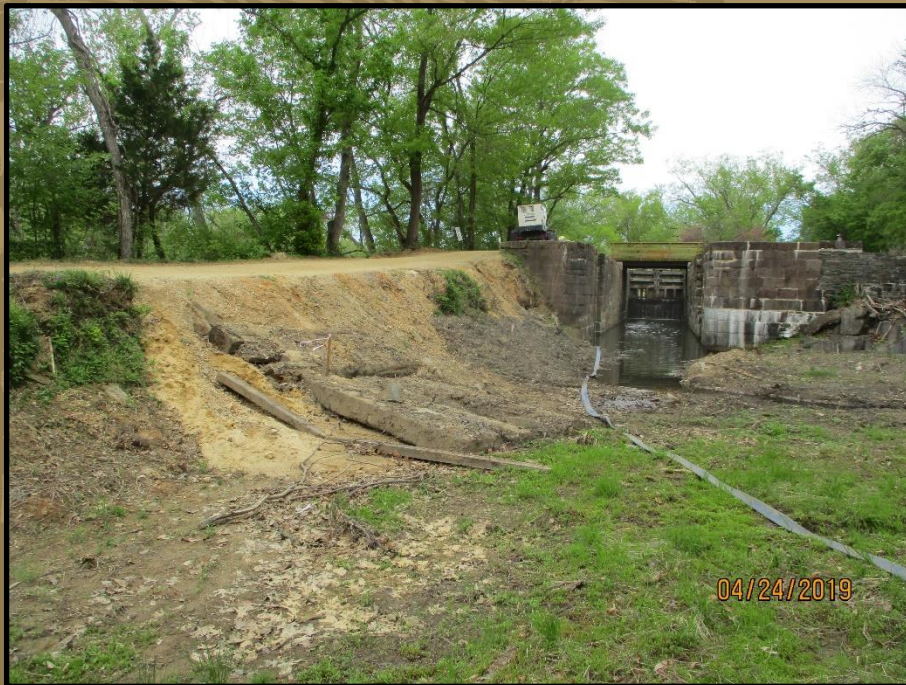
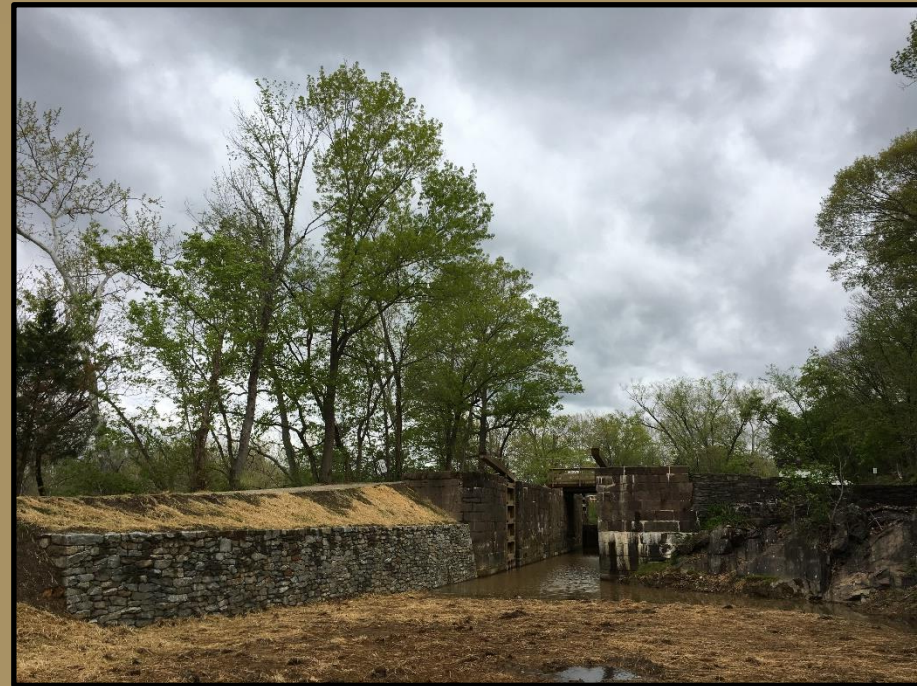
Towpath Retaining Wall Downstream of Lock #19 Repair

Before

After

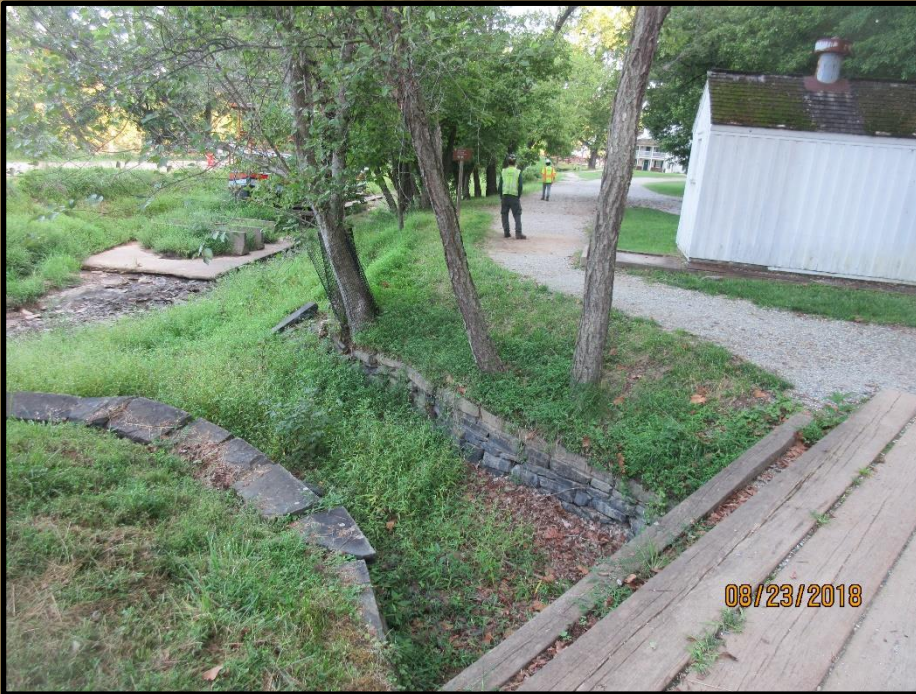
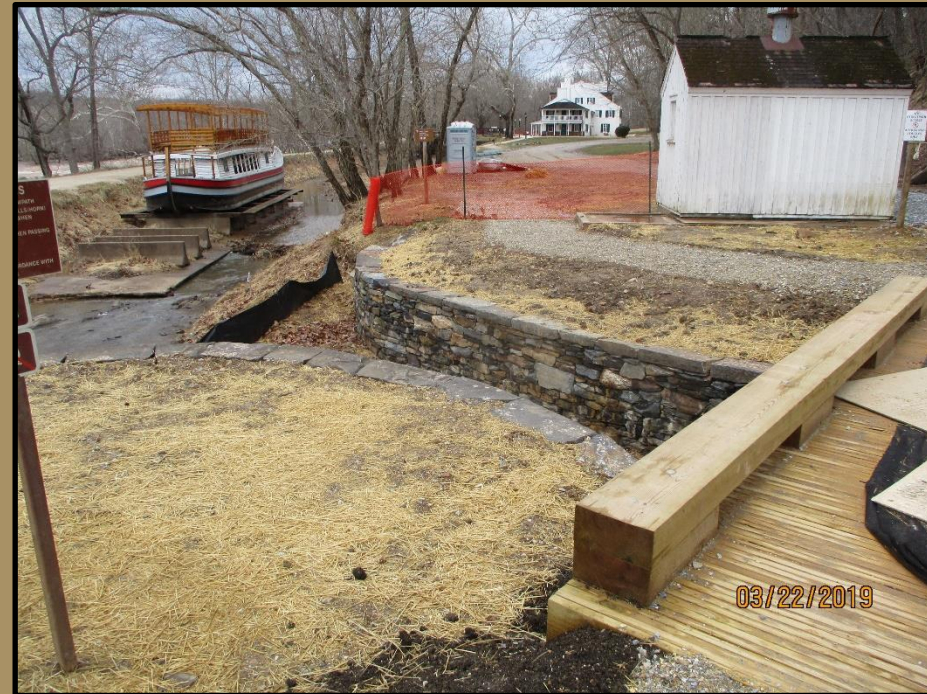
Lock #19 Canal Wall Repair

Before

After

Bridges over lock and flume replaced, flume walls rebuilt, lower lock gate replaced and upper repaired, and masonry repairs were also completed!

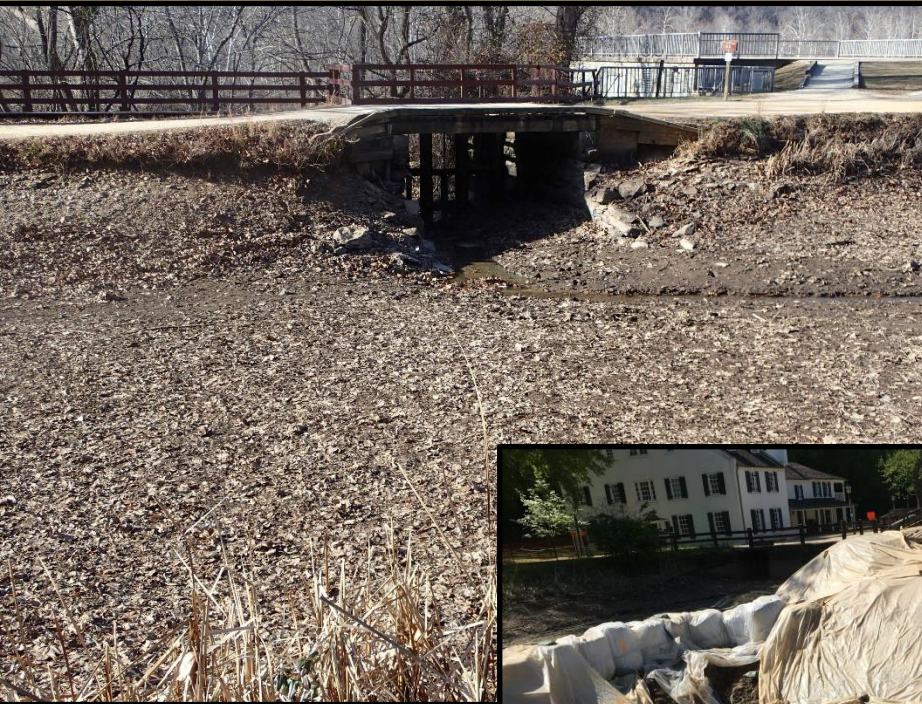
Level #20 Wastew weir Repair

Before

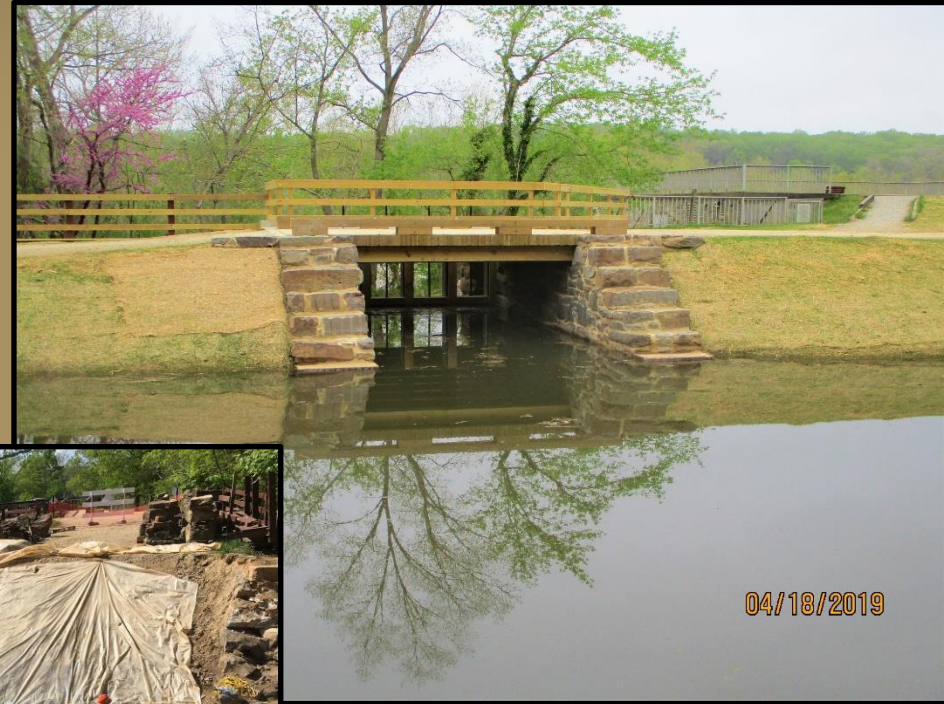
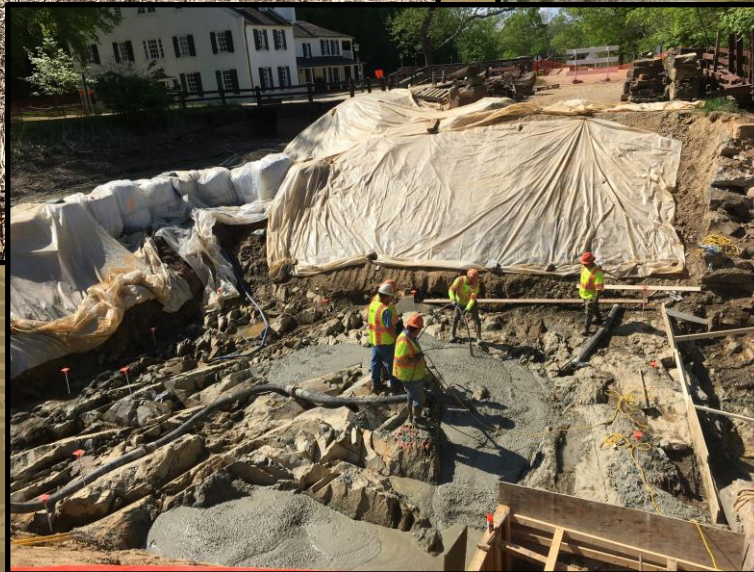
After

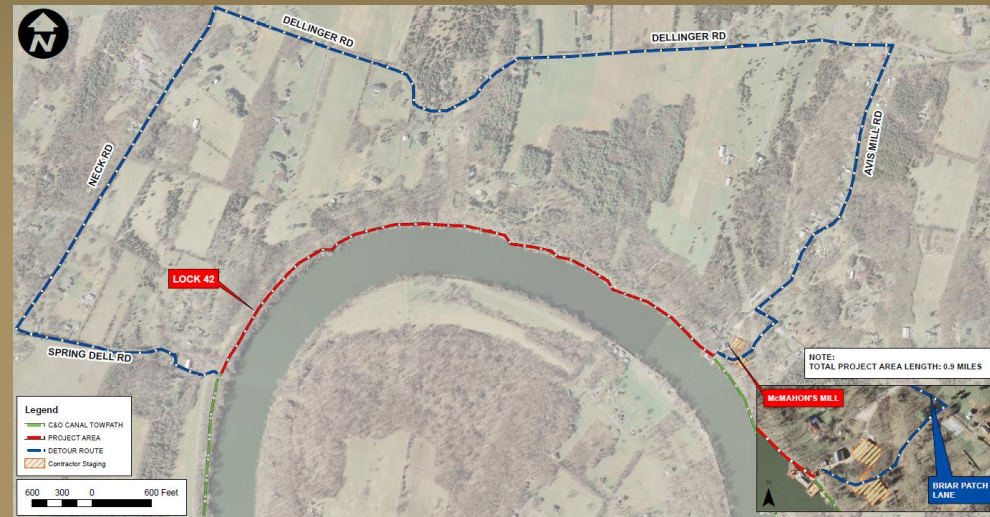
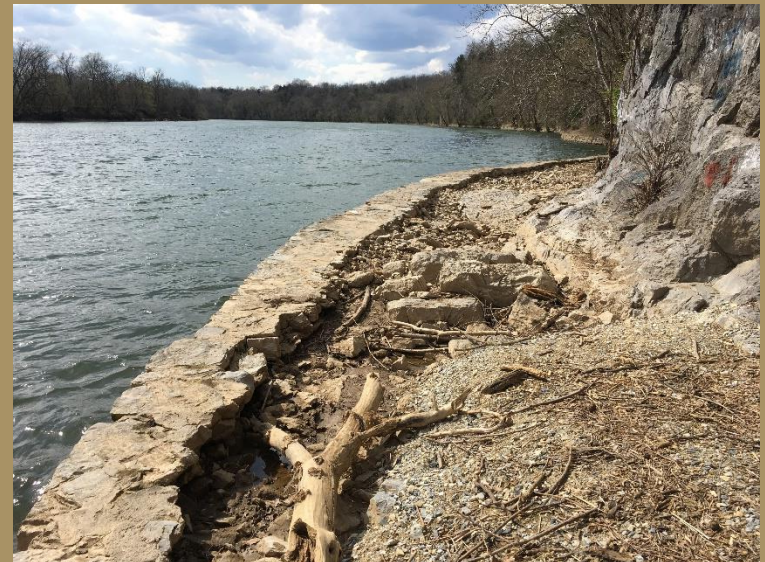
MM: 88.1 - 89 (Washington County, MD)

- Awarded construction project to rehabilitate & stabilize an approximately 0.9 mile stretch of towpath along the Potomac River. Towpath is currently closed & detour activated. Construction expected to continue into Spring 2023 (weather dependent).
- The work generally includes:
  - Site clearing and grubbing – Tree removal
  - Repair of existing mortared and dry laid stone wall
    - Stone infilling, chinking, and/or scour repair
  - Reconstruction of missing or failing dry laid stone wall to match existing
  - Raising of stone wall and towpath
  - Culvert Replacement
  - Laid Back Stone Revetment Repair
  - Excavation and Backfill
  - Towpath repair and resurfacing
  - Site Restoration/Stabilization

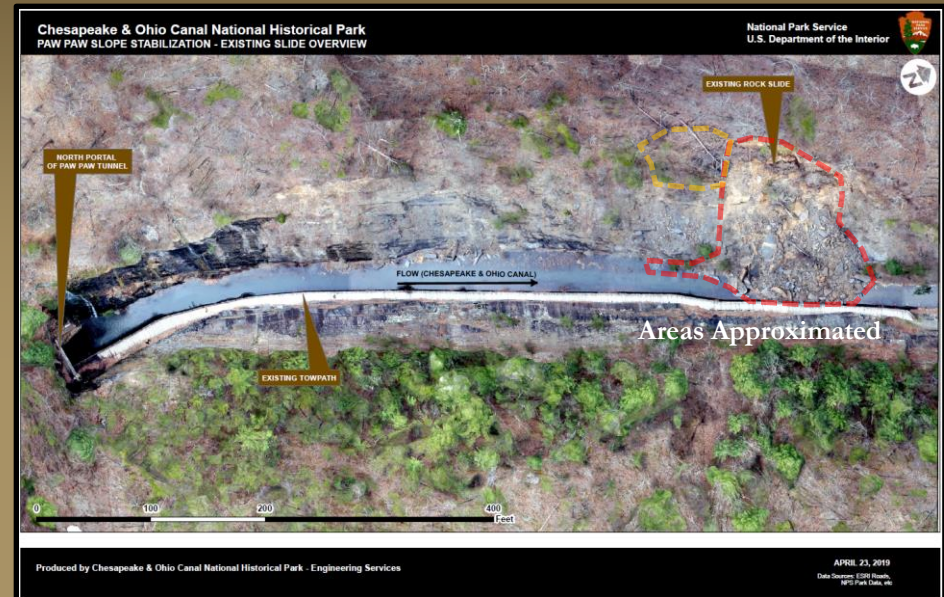
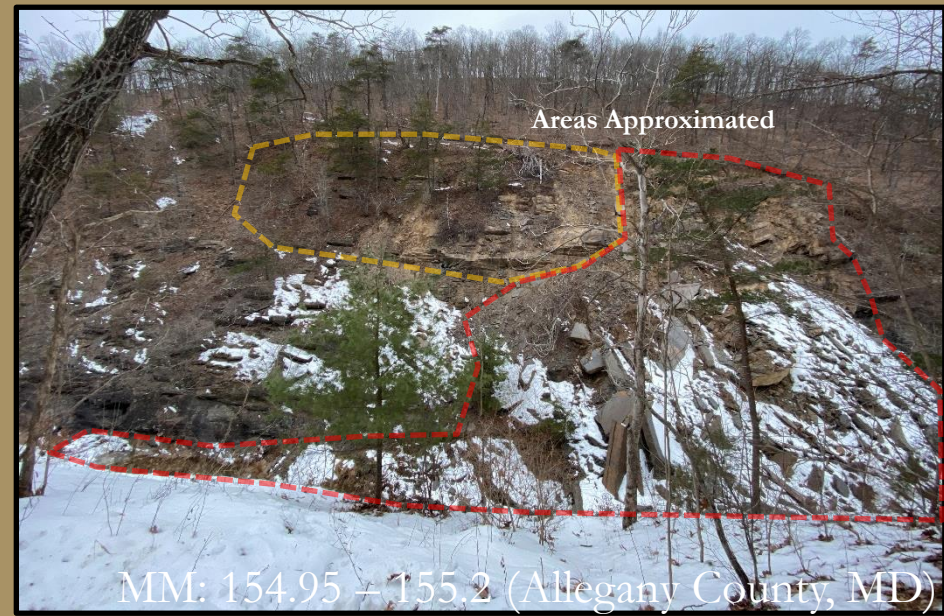
- Design-Build contract ongoing with construction started. Towpath currently CLOSED.
- Project will address unstable rock masses by stabilizing the highest risk rock slope areas:
  - Rock Scaling
  - Rock Bolting
  - Pinned Netting
  - Shear Keys
  - Drainage Improvements
  - Replacement of Boardwalk

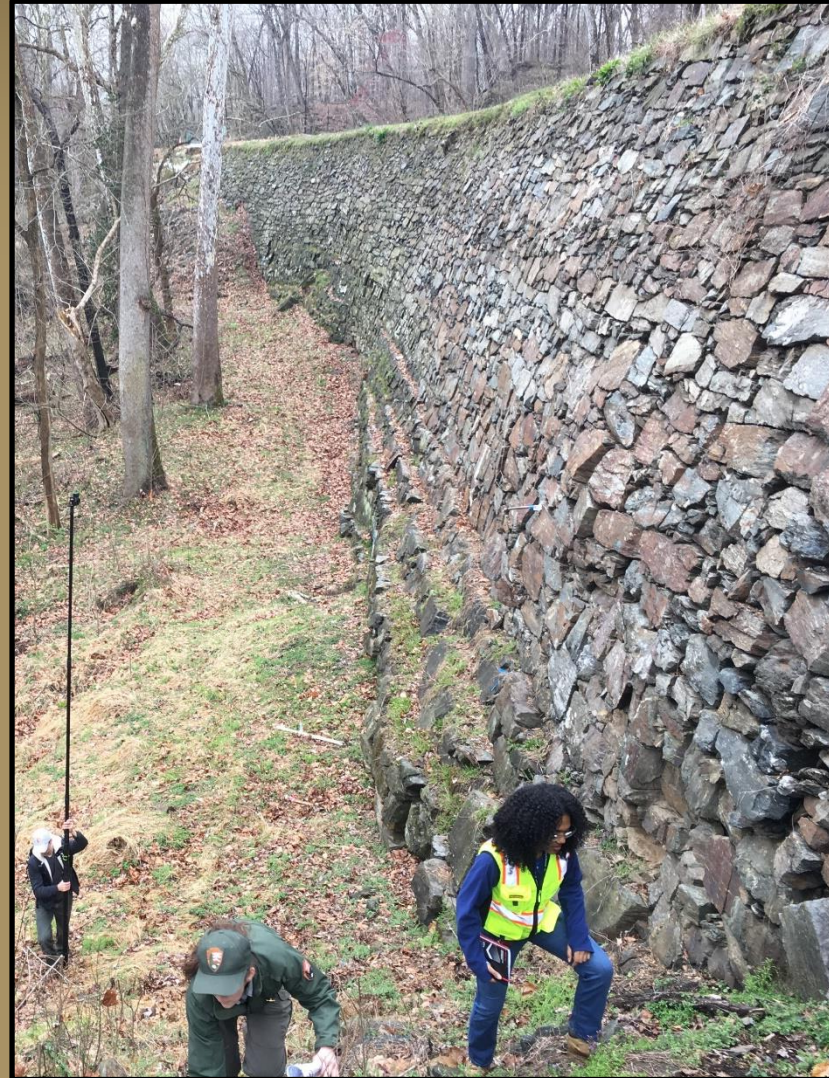
- Currently developing complete construction documents for the stabilization of an approximately 1,015-LF long drylaid stone wall that varies in height up to 35' tall which was constructed in the 1830's. Construction expected to begin within the next year once design can be finished and permits acquired.
- Sediment will also be removed from the canal to restore the flow capacity and replace the canal liner system.
- To see the wall in 3D use this link:  
<https://skfb.ly/6SruX>
