Pedal, Paddle and Hike

Tonoloway Creek Aqueduct and Environs

Mile 122.50 to 122.59, Hancock, Maryland

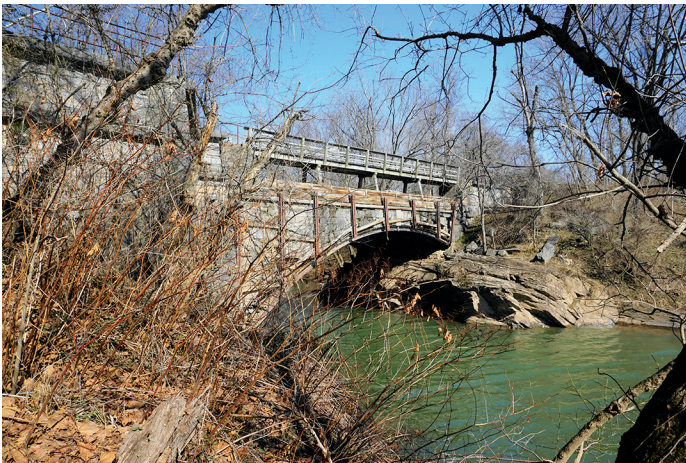
Above – Tonoloway Aqueduct from the Potomac

Tonoloway Creek Aqueduct (also known as Great Tonoloway or Bowles Aqueduct) is unique in being the only asymmetrically arched aqueduct on the canal. This was done due to the difficulty of the steep rocky terrain at the mouth of Tonoloway Creek. The creek narrows between two red shale, siltstone, and sandstone bluffs just before entering the Potomac. The downstream side is higher than the upstream bluff. Robert Brown was the contractor who built the aqueduct and completed work in the summer of 1839. Originally a timber waste weir was built into the downstream side of the aqueduct stonework to allow water to be drained into the Tonoloway Creek as well as adding a measure of flood control. This weir was later replaced by a concrete weir structure.

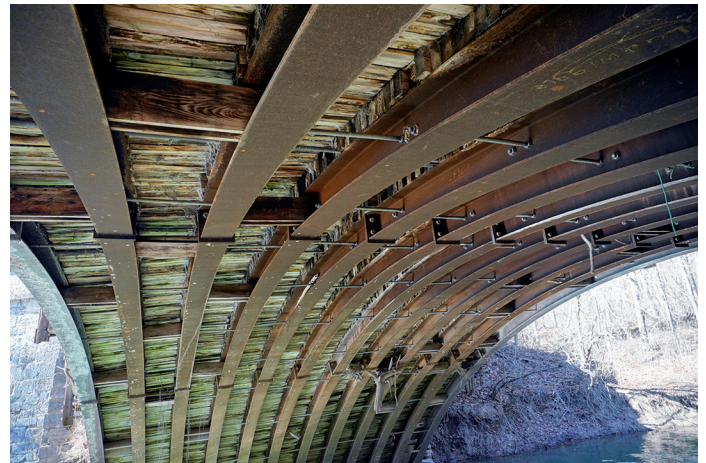
Above – Some of the intricate structural steel support structure under the aqueduct's single arch

Structural issues still plague this unique aqueduct. The National Park Service installed extensive steel bracing in 1979-80, with timber used as padding. This support structure in its complexity is almost as impressive as the original stonework of the aqueduct.

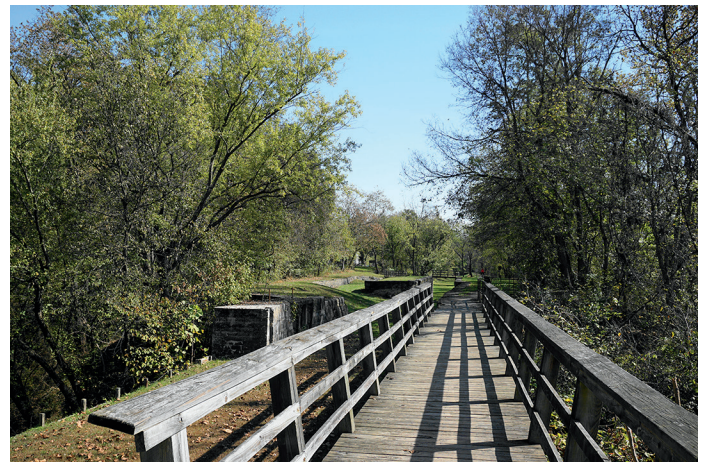
Below – The wooden walkway across the aqueduct that approximates the early repair

strong enough to take the weight of the stone above it. Part of the problem was uneven loading due to the non-symmetrical arch; one side had to handle more of the weight distribution than the other. On a symmetrical arch, pressure is evenly distributed downward onto a pier or end wall, in effect making the arch stronger than its constituent parts. To alleviate this problem, some stone was removed on both the towpath side and the berm side to lighten the load on the arch. The stone was replaced with a timber wall on both sides to retain water and a wooden walkway was added on top of the river side wall to serve as the towpath. Concrete was used as an early repair to the aqueduct's prism's floor to add strength.

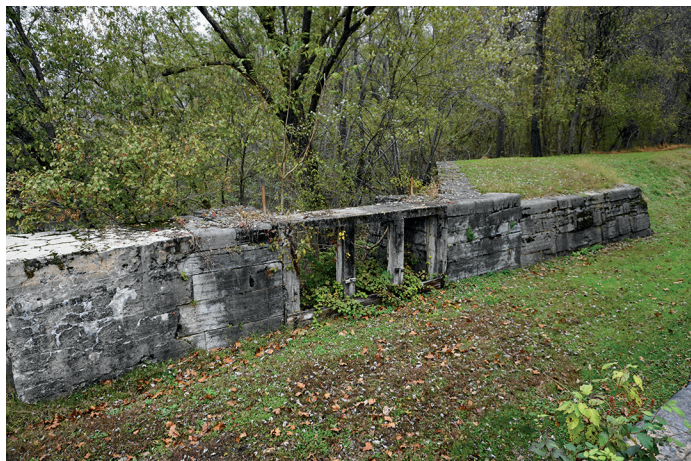
Above – A waste weir is built into the aqueduct structure on the berm side

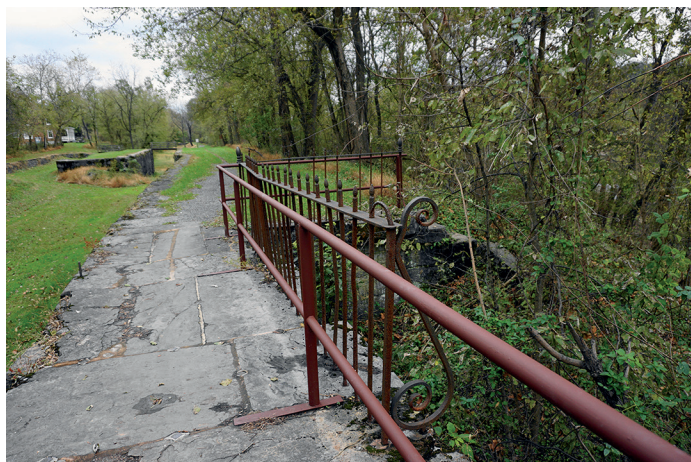
Below – Some of the original wrought iron railing can be observed on both ends of the aqueduct

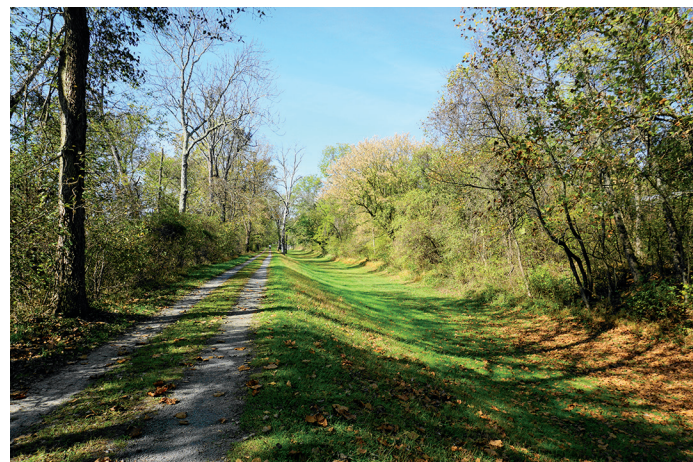
Below – The view of the canal prism looking upstream from Lock 51 towards the TonoLOWay Aqueduct

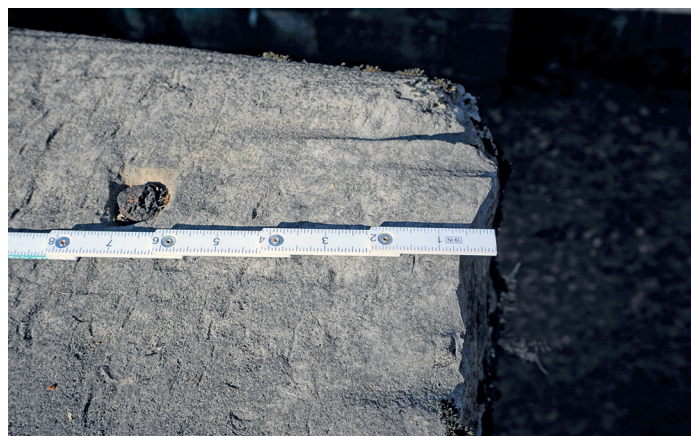
Rope "burns" on the edge of Lock 52

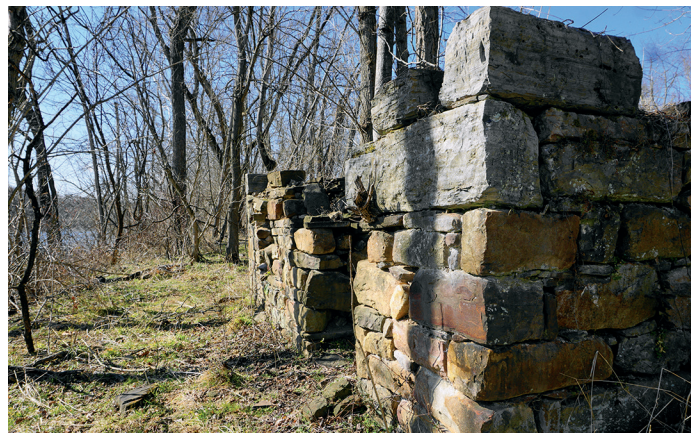
The beautiful stone work on the back basement door of the house near Locks 51 and 52. The mix of red shale and limestone blocks used to construct the house.

Lock 51, at Mile 122.96, was also built by William Storey in the fall of 1838. On the river side of the lock are the remains of the one and a half story lock keepers house. The 18 by 30 foot limestone and red shale stone lock house had a stone foundation on a full basement. The wooden floors and support beams and roof no longer exist, but the central chimney with two opposing fireplaces remains.

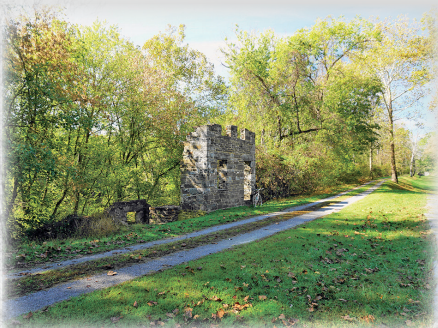
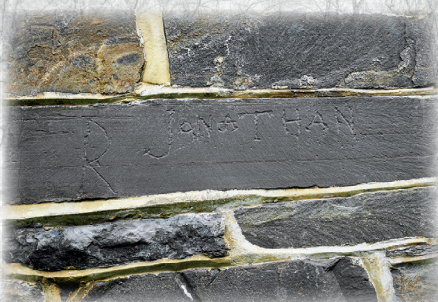
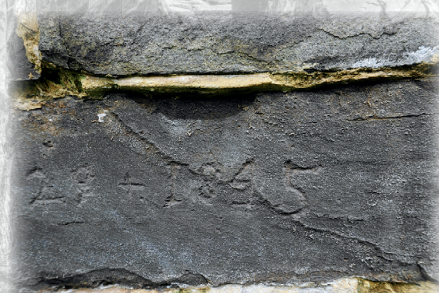
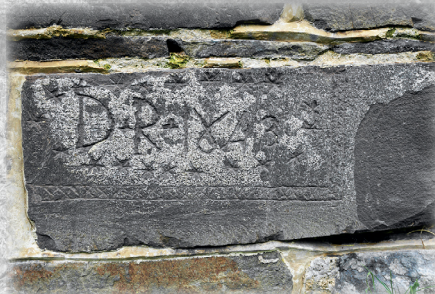
On a stone between the door and window "Upton Rowland March 29 1843" is inscribed. "D Rowland+AD" and "Upton Rowland March 29 1843" are inscribed on other parts of the house. "R Jonathan" (left) is also inscribed on the front of the house.

An inscription "Upton Rowland+ March 29+ 1845" is below a front window (right).

A very typical styled 19th century decorative carving "D-R-1843" is shown to the right. This inscription has a decorative "X" border with chiseled stars surrounding the initials and the date. The carver used the natural light color concretion on the face of the stone to enhance the carving.
