Accompanied by the Past *By Karen Gray*

Canal Engineering from Dam 3 to Harpers Ferry

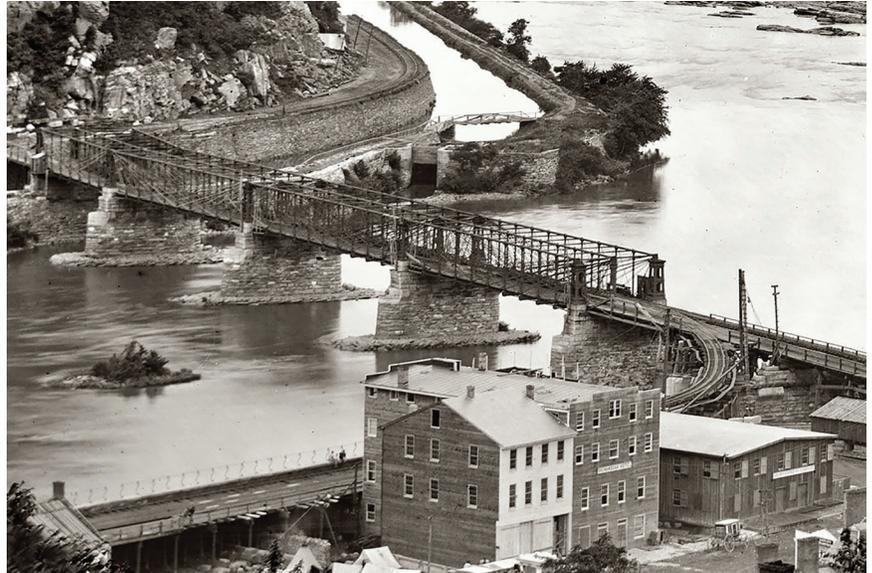
View of the river lock, 1865 – Courtesy Shorpy.com www.shorpy.com/node/3436

Although little of the river lock remains except for a small amount of the stone at the canal end, this lock would have been very deep as it was, in effect, a vertical elevator from the bottom of the river pool to the surface level of the canal prism at the top. Because the current towpath is lower than it was in historic times, and the river end is missing, it is hard to appreciate (or precisely calculate) the depth of this lock.

gate design at the river end: a wall of heavy planks is in place across the upper part of the area for the gate and miter gates are below it, the top of which appear to be flush with the bottom plank (likely forming an effective seal). The means by which the gates were opened and closed would have had to extend from the top of the lock down the plank wall to the gates below. Obviously also, the wall was high enough to allow boats to pass under it.
