Pedal, Paddle and Hike

How to Save Water and Fix a Broken Canal Or The Perils of Geology

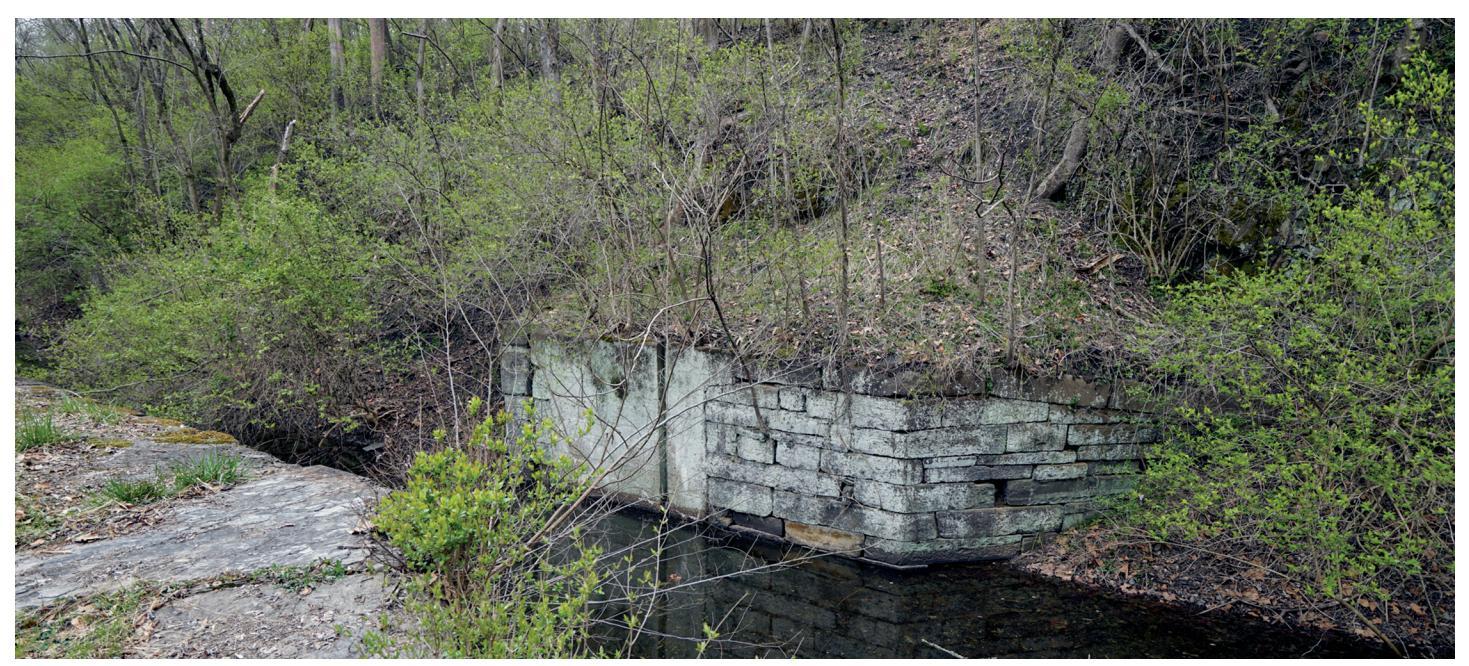
Stop gate at McCoy's Ferry – All photos by Trent Carbaugh

What this meant for the canal, in some spots, is that sinkholes can form when the underlying limestone structure collapses due to voids caused by underground water flow. This was very bad if it happened in the canal prism. A large sink hole exists in the prism just down from the stop lock at McCoys Ferry.

At the downstream end of Little Pool there is a stop lock, almost exactly like the one at McCoys Ferry, that has slots for a plank gate. This stop lock is built a little downstream from the end of Little Pool quite likely again as protection from ice expansion. Little Pool is substantially smaller as well as shallower than Big Pool.

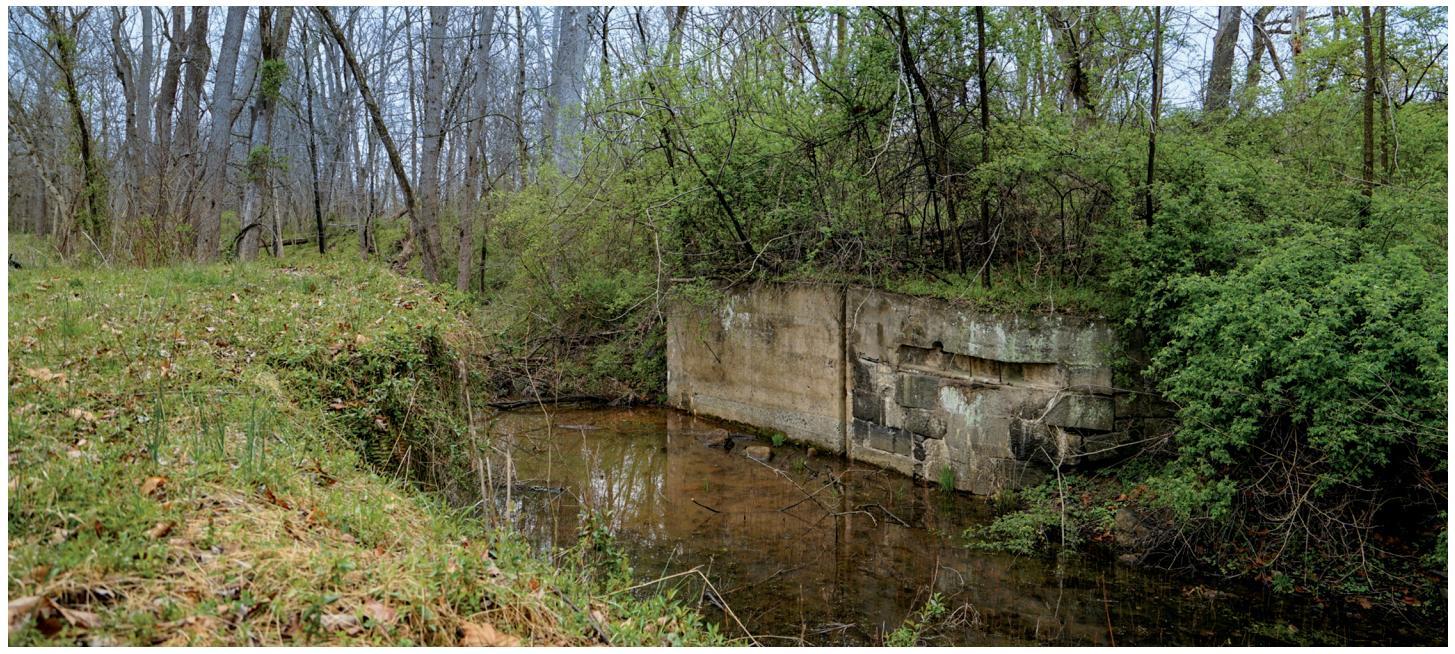
Stop gate at the western end of Big Pool

At the far upstream end of Big Pool there is another stop lock of more conventional construction with slots for plank gates. Unfortunately, this stop lock is not in great shape and shows extensive historic repairs.

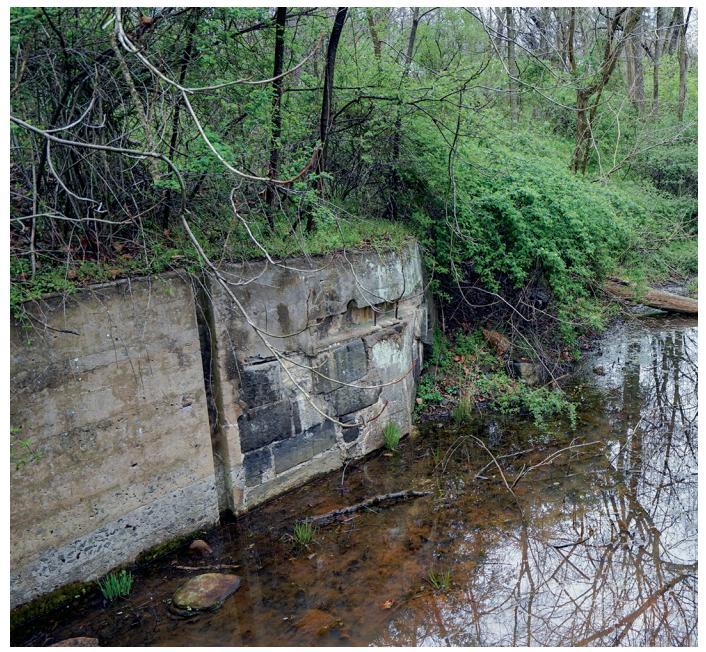
A view of the Big Pool western stop gate plank slot

Many stop locks on the C&O Canal were closed with plank "gates" where heavy boards were slid into slots built into either side of the lock walls. These boards were probably quite wide and judging by the width of the slots at least 2¹/₂ to 2³/₄ inches thick. Most likely some sort of portable winch system was used to place and remove the boards though I could not locate any information on this. Plank gates were probably preferred as they weren't used very often and wouldn't require the regular maintenance that normal miter or drop gates required.

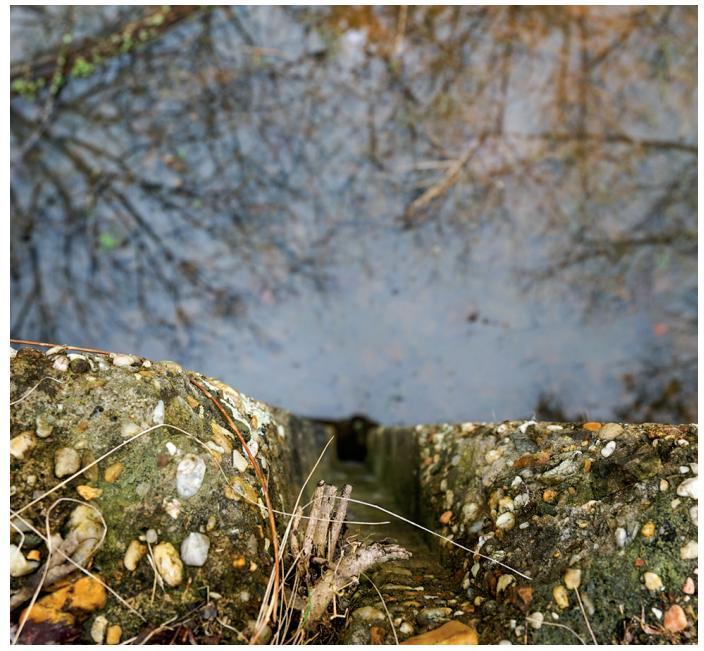
Plank slot in a stop gate

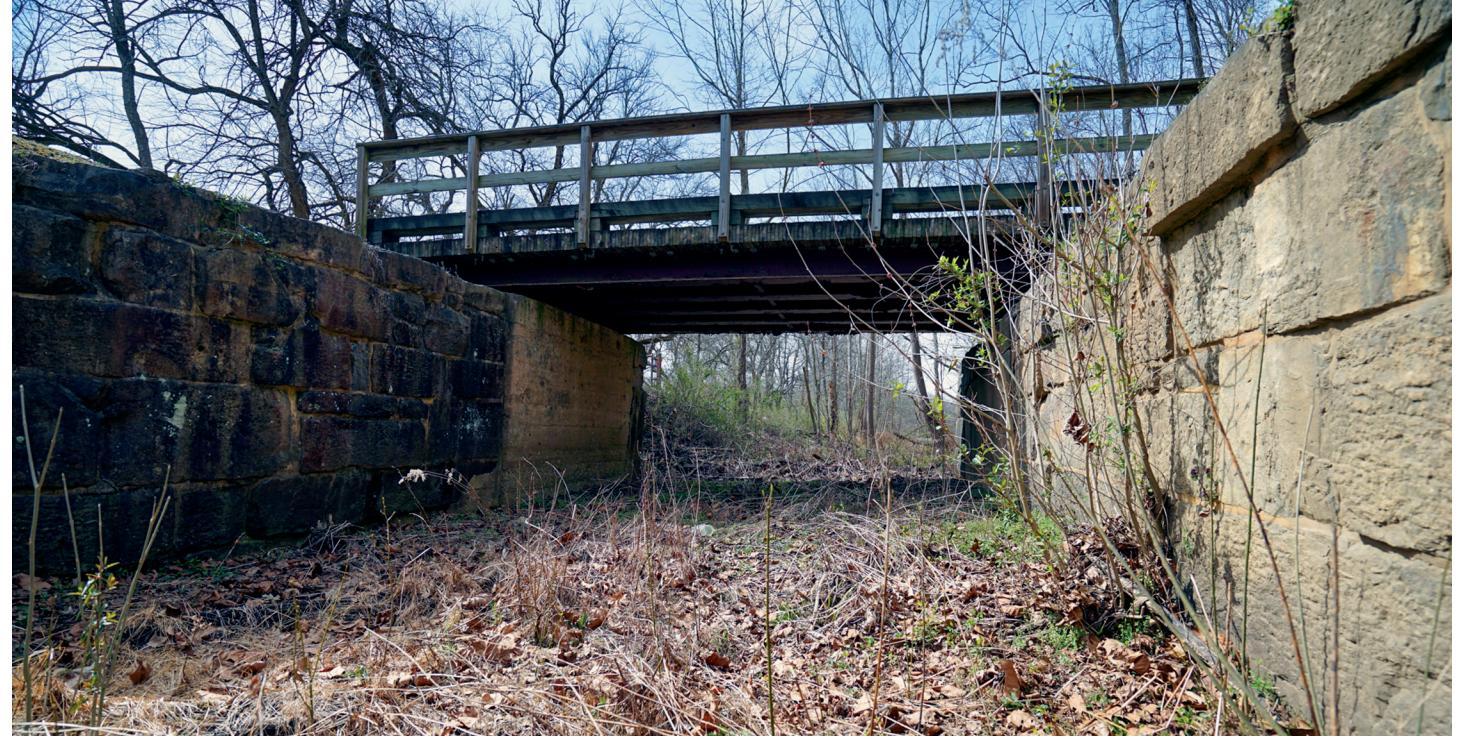
Stop gate at east end of Big Pool. There was a drop gate here as well as the mounting foundations for a swing bridge. The swing bridge remains are at the west end of the gate.

Two unique features in this section of the canal were Big Pool and Little Pool. These man-made lakes served as water reservoirs for a large portion of the canal and could be closed off during the winter. Big Pool had a stop lock with a drop gate and presumably the machinery to open and close it. This stop lock also has slots for a plank gate which may be an addition as it is from a later 19th century concrete repair to the lock chamber. A double lock may also have been prudent as Big Pool was left full over the winter and froze to a thickness

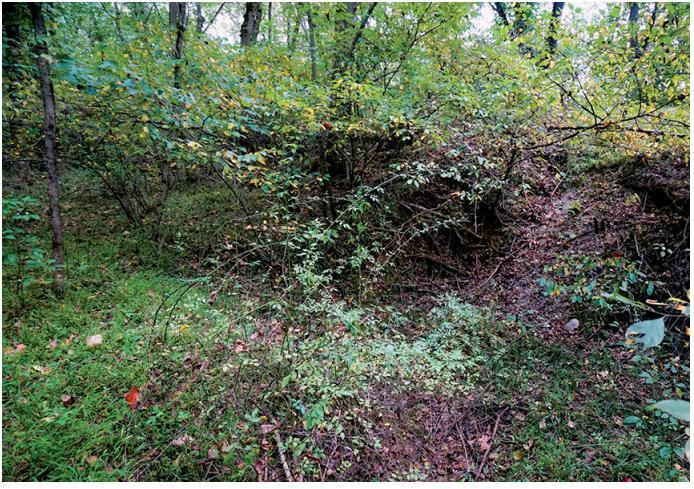
Sinkhole in the canal prism close to McCoy's Ferry

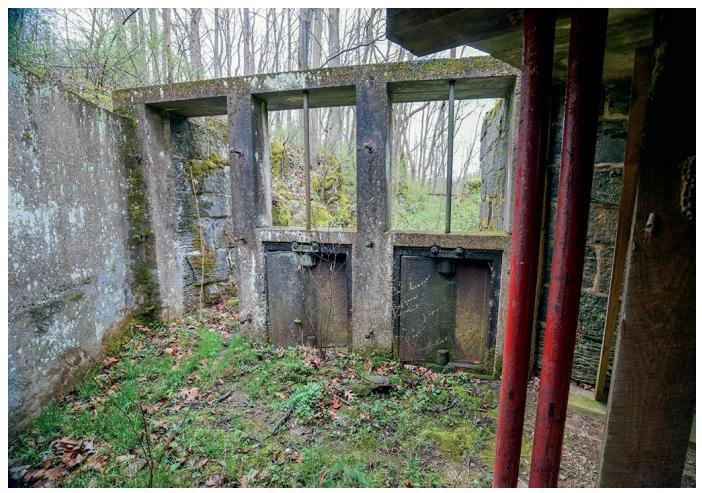
Butterfly gates in the waste weir above Lock 50 at Four Locks

In order to facilitate ease of repair and interrupt canal traffic as little as possible, some mechanism was needed to isolate smaller sections of the canal in some areas. Stop locks were used to "stop" water movement in the canal prism. Many of these locks were used for water management during the yearly winterization of the canal. But other times it was necessary to block off a section of the canal for repairs, such as at McCoys Ferry. A large sinkhole in the canal prism would be like pulling the plug on a full bathtub; the water would disappear quickly. The stop lock would have been closed along with the upstream gate of Lock 50, the uppermost lock at Four Locks, and the waste weir just above Lock 50 would have been opened to drain this section of the canal in order to do needed repairs.

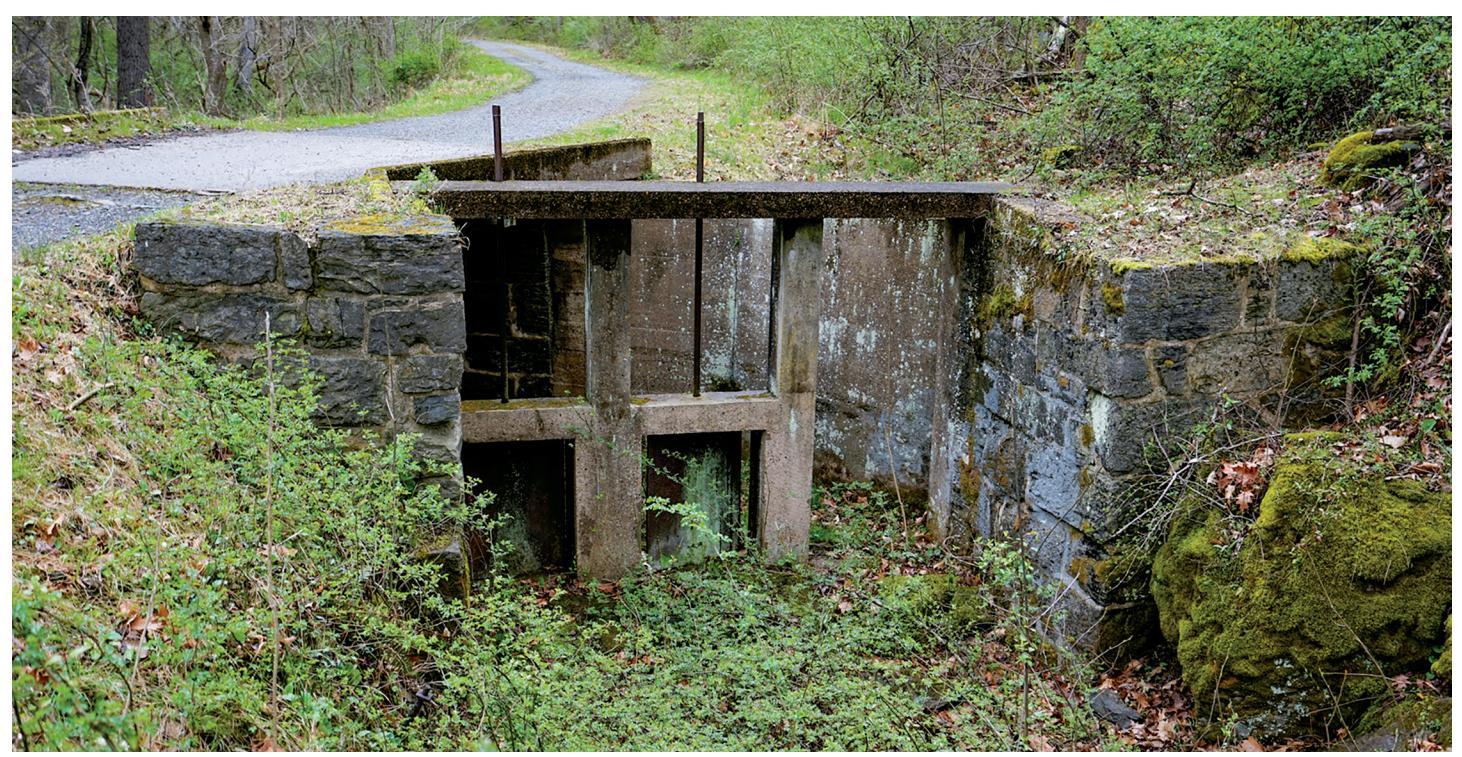
Waste weir above Lock 50 at Four Locks
